Analysis of road safety before and after road safety assessment carried out on the road section no. 16 Banja luka – Celinac, intersection “Groblje-Vrbanja”

This paper presents a concrete road safety inspection of intersection on the primary road (major road) M4 in the place Vrbanja near Banja Luka. The said intersection is where the major road and access road to newly constructed cemetery in Banjaluka intersect. After the inspection, the Public Company “Republic of Srpska Motorways“ as road administration implemented some recommendations from the final Report on road safety inspection in order to improve these procedures.

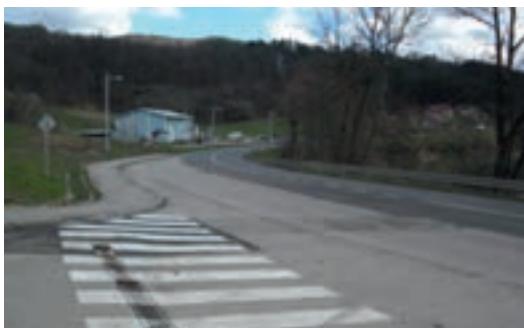
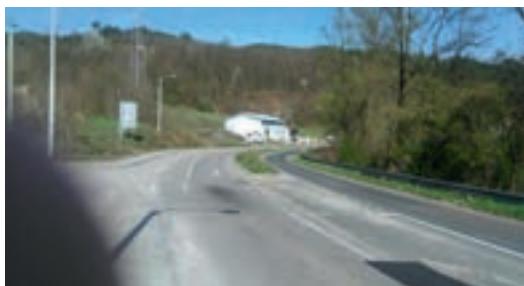
Partial reconstruction has been made in the zone of the subject intersection, whereby channelling island was constructed in the length of ~128 m, while channelling island was physically constructed at the length of ~90 m, and the remaining part is in the form of horizontal traffic signalisation.

Picture 2. Condition on the subject spot from 2011 (Google earth, 25 October 2016)

Picture 3. Condition on the subject spot from 2016 (Google earth, 25 October 2016)

Within medium-term measures, a reconstruction of the intersection is envisaged, with special accent on the channelling island on the direction towards Čelinac with recommended length of at least 250 m, as well as construction of a bus stop that is a lay-by.

Long-term measures predict reconstruction of the subject intersection and turning the current three-leg crossroad into roundabout.

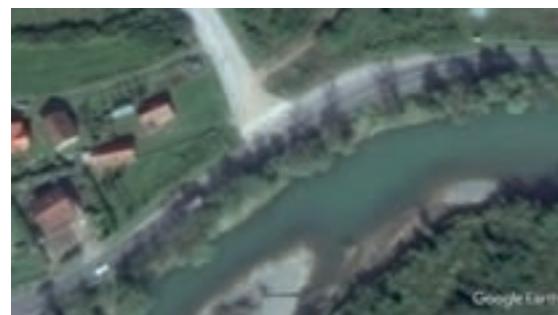
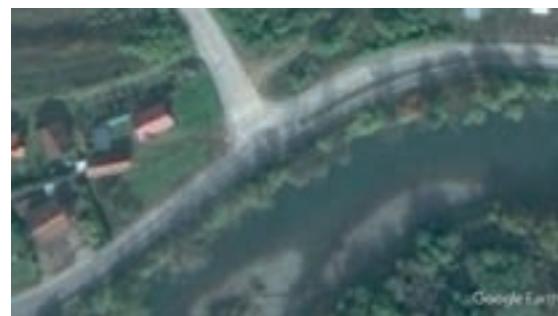
Compared to the analysed conditions, no change in the horizontal geometry of the road occurred so that the same curves are retained in the same conditions as recorded in the course of the year 2014.

Picture 4. Condition on the subject spot from 2011 (Google earth, 25 October 2016)

Picture 5. Condition on the subject spot from 2016 (Google earth, 25 October 2016)

Due to the overgrowth and trees on the right side of the road when looking from the direction of Čelinac, horizontal visibility is still reduced at the right curve.

Neither short nor medium-term measures presume the change of horizontal geometry of the road in the zone of the subject intersection, while long-term measures suggest correction of the horizontal geometric elements of the road.

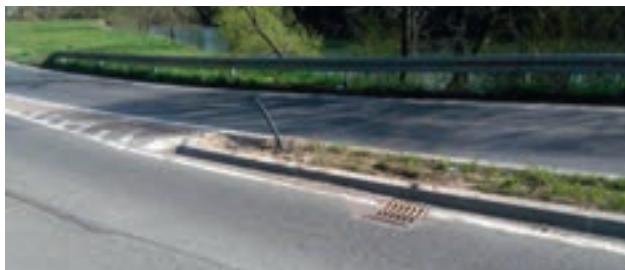
Picture 6. Condition on the subject spot from 2016 (4 March 2016)

According to the above stated, it can be concluded the channelling island was not constructed in the right manner and in appropriate dimensions so as to make it visible to all motor vehicle drivers.

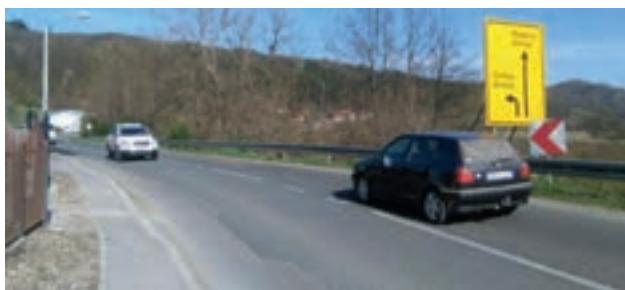
Picture 7. Condition on the subject spot from 2016 (4 March 2016)

From the direction of Banja Luka (Picture no. 7), a separate left-turn lane was constructed ($n=2$), which prevents vehicle congestion, while the traffic signalisation that marks the spot where the sharp curve starts (sign "Direction post" (III-71) and (III-72)), was installed in an appropriate manner, which can be said for another direction as well (from the direction of Čelinac).
