# Passive Road Safety Systems - Case Study Of Road Section Banja Luka - Prnjavor (M16, M16.1)

## CASE STUDY (BANJA LUKA - PRNJAVOR)

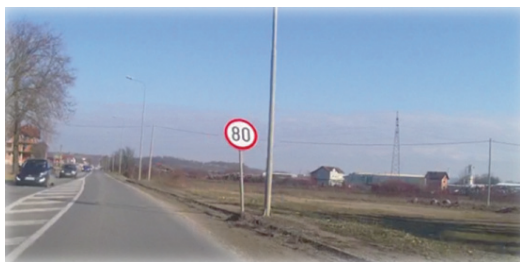
In Figure 3. we can see an example from a real life situation. That even if the speed limit is 80km/h the poles are located very close to the edge of the driveway and extend on the right and left side of the road to the entire length of the segment of the specified speed limit. [7]

Figure 2. Iron poles in the speed limit zone of 80km/h (M16.1).

It should be noted that in such cases even if the speed limit is 80km/h the speed of the vehicles is predominantly higher than permitted for as much as 30km/h in some cases. For such segments of the road, it is necessary to protect the roadside disturbance (poles) by the setting of the rebound fences, so that the poles are not in the working width of the same fence or completely replace the existing poles with passive safety poles where this is possible.

- Replacement of concrete and iron poles with passive safety poles where possible;
- Where the replacement of existing poles is not

possible, it is necessary to protect the poles with appropriate crash cushions especially for zones 50km/h and zones over 70km/h;

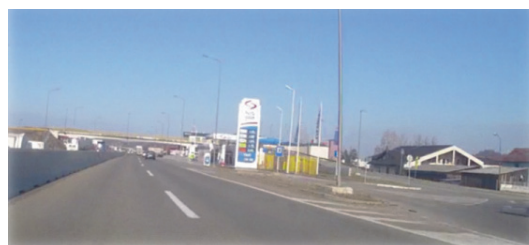
the exit ramps as in Figure 4. where the poles are completely exposed to the external traffic impact.

Figure 3. Pole exposure (M16)

In this road section, vehicle speeds exceed 100km/h, making this a relevant hazard. And if so far there have been no cases that a vehicle hit that unprotected pole, that does not mean that tomorrow will not happen. Therefore, it is necessary to react preventively and not wait for a serious traffic accident to happen, and then only apply certain measures that will be corrective in this case.

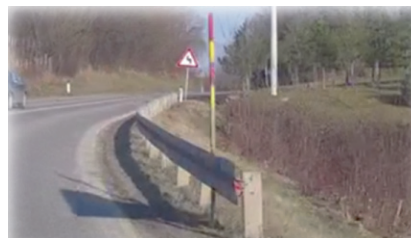
*The frontal open beginnings of rebound fences* pose a major problem in the entire observed section. The example from Figure 5. shows the open start of the rebound fence on the road section Klašnice - Prnjavor (M16.1).

Figure 4. Open start of the rebound fence (M16.1)

The open start of the rebound fence acts as a kind of blade when the vehicle in motion hits it, so we have an opposite effect of the fence here. Instead of turning away the wandering vehicle that hits the fence back on the driveway or in an another case safely stopping it along the length of the fence, the vehicle hits directly the metal structure which, at that speed, becomes a "blade" that breaks through the chassis of the vehicle. In addition to the open beginnings and endings of the rebound fences, they're mostly in a bad state. Primarily because of previous vehicle accidents and insufficient fixing after accidents. In some places the fences are not placed at the appropriate height and are not connected in an adequate way with the attachments of other fences. The explanation for this situation lies in the fact that these fences when first placed were adequately furnished. But because of insufficient maintenance of infrastructure and poor remediation after traffic accidents they've lost all their functional aspects in time and now they have almost no effect on reducing the consequences of a traffic accident. In some cases they can act contrary to what they are intended for and increase the consequences for passengers in the vehicle and for the vehicle itself.

- Fixture or replacement of the rebound fences that have been damaged during vehicle collision;
- The beginnings and endings of fences must be executed out in the right way so that they do not have a sharp beginning and end that can break through the front of the vehicle. The beginning must not be in such a form to catapult the vehicle into the air during collision.

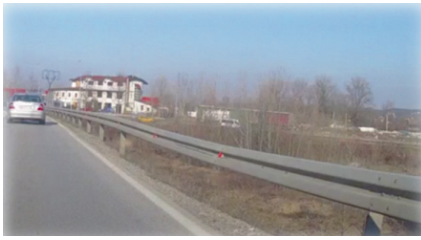
**Figure 5.** Poor maintenance (M16.1)

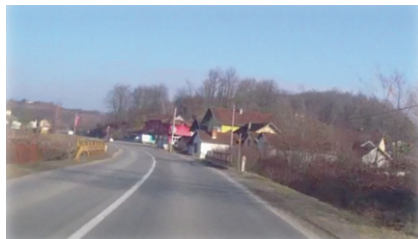
The approaches and the fences on the bridges are also one of the critical points on the observed section. There are openings between the protective fences on the bridges and the frontal rebound fences. And in this case, the ending of the rebound fence is in most cases open. As far as the protective fences on the bridge are concerned, they are mostly in poor condition or not present on one or both sides. The approaches to the zones of the bridges are not adequately protected. The rebound fences, if any, do not protect vehicles from possible landings in slopes in the zone from 20 to 50 meters before the bridge. They are placed before the beginning of the bridge or are not at all positioned.

**Figure 6.** Unprotected approaches (M16.1)

Before and after the bridge, there are no rebound fences that would prevent the possible landing of the vehicle into the slope before the passage. It is necessary to install a rebound fence of an adequate length before the passage and after the passage, so that possible exit of the vehicles in that zones are prevented. Rebound fences should be connected with the fence on the bridge, the pedestrian zone if present, should be protected from the external influence of traffic of motor vehicles. Fences on bridges are in a catastrophic state in most cases or do not

exist at all, so this aspect should be solved by placing adequate certified protective fences.

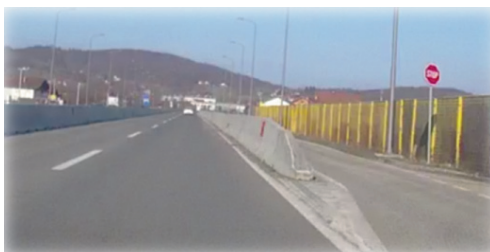
New Jersey barriers are present only on the road reserved only for the traffic of motor vehicles M16 Banja Luka - Klačnice. Their function is to physically separate the driveways. In the majority of cases, one line of these barriers is enough but there are two lines on the M16 path for reasons that are not defined. Roadside disturbances on this section are largely adequately protected, but the beginning of the new jersey barriers are a problem if a moving vehicle hits one of them. Any beginning is not protected in any measure, and it also represents a sort of a catapult for a vehicle in case of a collision.

**Figure 7.** Unprotected new jersey barrier (M16.1)

On the road reserved only for the traffic of motor vehicles M16 there are several New Jersey barriers whose beginnings are not protected in any measure and some of them have already traces of vehicle impacts. Since speeds on this road are more than 100km/h, adequate protection and prevention of catapulting vehicles in the event of a collision is a must have thing. [11]

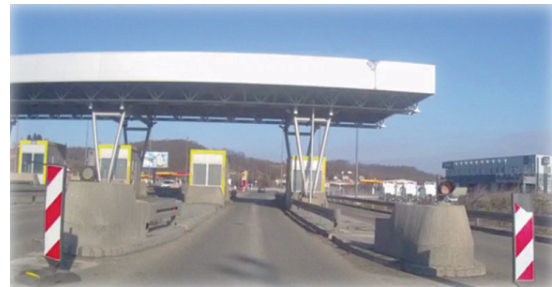
An additional indispensable item on this section of the road are the payroll booths that are not in operation and currently present, in such a state, only an obstacle and endanger the safety of traffic due to their inadequate protection against possible vehicle collisions.

**Figure 8.** Payroll booths (M16)

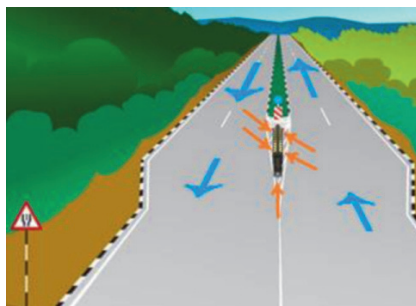
Figure 11. M16 example situation

Blue arrows indicate the direction of movement of the vehicles while the orange arrows indicate the possible directions of movement of the vehicles during an impact with the SMA end terminal.
