Nikola Miletić, University of Belgrade, nikola.miletic@arh.bg.ac.rs  
Dušan Ignjatović, University of Belgrade, ignjatovic.dusan@arh.bg.ac.rs  
Bojana Zevković, University of Belgrade, bojana@arh.bg.ac.rs  
Nataša Ćuković Ignjatović, University of Belgrade, natasa@arh.bg.ac.rs

## **ENERGY EFFICIENT REFURBISHMENT OF MUNICIPAL PUBLIC BUILDINGS IN BELGRADE, SERBIA**

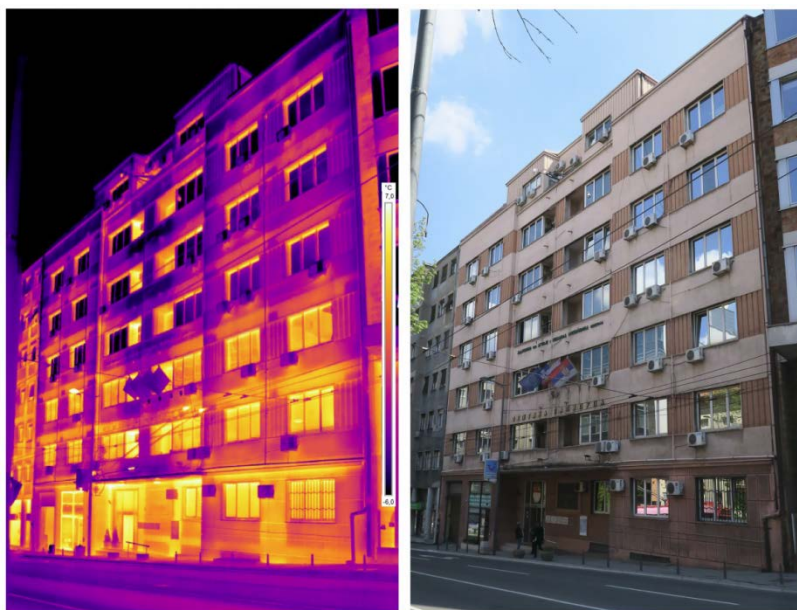
The existing windows are mostly made of PVC profiles and were installed in the early 2000s. During the exploitation, changes were made to the shape of the windows as well as their dimensions, so the current state is partially different from the original one. Although the existing PVC windows are in relatively good condition, they are, given their age, characterized by inadequate thermal characteristics, keeping in mind the current standards.

The building is supplied with thermal energy through a district heating system from the Public Utility Company of the Belgrade Power Plant using a radiator heating system. The radiator network is indented as not insulated within the thermal envelope of the building.

Figure 1. *Thermal imaging and photograph of the street facade of the building of the City Municipality of Palilula. The image clearly shows heat losses in horizontal reinforced concrete cerclages as well as beams over windows. No vertical reinforced concrete elements are observed*

- Replacing existing PVC windows with new ones, with six-chamber PVC profiles with triple glazing filled with argon and low-emission coating. The geometrical characteristics of the newly planned windows (size and composition/division) are the same as existing ones, but the newly planned windows are characterized by a better heat transfer coefficient of  $U = 1.5 \text{ W/m}^2\text{K}$ .

- Thermal insulation of the courtyard facade was performed by placing a thermal insulation layer of 12 cm of stone wool over the existing facade.
- Thermal insulation of the courtyard facade overhangs was performed by placing a layer of stone wool 15 cm thick and a final layer of cement mortar.
- Thermal insulation of mezzanine structures towards the attic space was performed by installing a layer of 15 cm stone wool with the addition of appropriate protective layers (steam dams, protective foils) in accordance with the requirements of building physics.
- The thermal insulation on the part of flat roof was planned. A 20 cm layer of stone wool on the underside and finished with plasterboard on the appropriate substructure.

- Thermal insulation of the street facade was performed by installing a thermal insulation layer of 12 cm of stone wool. The street façade is characterized by relatively reduced façade plastic,

and the intervention removed all layers up to the load-bearing layer of the wall and reworked the façade in accordance with the existing condition in terms of material and geometric characteristics. Work on this façade would require a long-term disruption of pedestrian traffic since the walkway in front of the building is very small so therefore this intervention is not included in the second scenario.

- Thermal insulation of pitched roof above the attic office space was performed by adding a thermal insulation layer of 22 cm of stone wool between the existing rafters. This roof already had 12cm of thermal insulation and works on the inside of the roof would require eviction of offices and demolition of existing finishes so it was therefore not part of second improvement strategy.

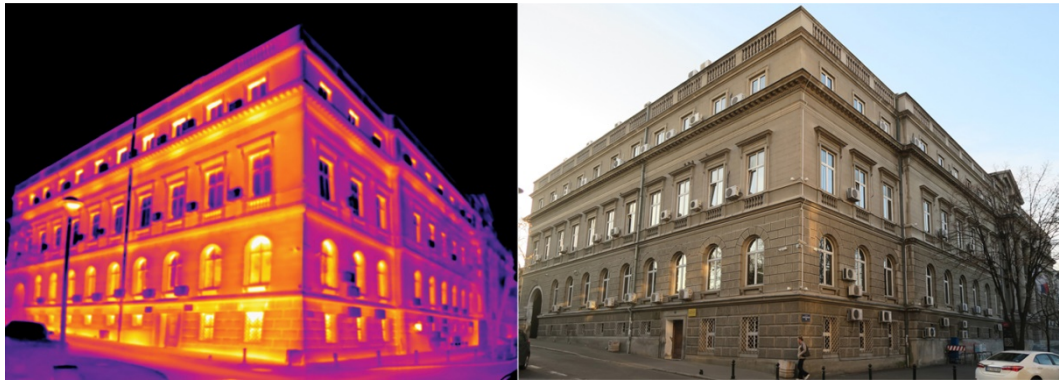
The available project documentation cannot determine the existence of reinforced concrete elements, as well as thermal imaging conducted during the energy audit, except in the extended part of the building. (see Figure 3)

Figure 3. *Thermal imaging and photograph of the street facade of the building of the City Municipality of Zemun. Heat losses are evident in the area where concrete beams are - over windows and in the area of window openings*

- Replacing existing PVC windows with new wooden ones, according to the conditions obtained from the Institute for the Protection of Cultural Monuments of the City of Belgrade. The newly planned solid wood windows are glazed with thermopane glass with geometric characteristics (sash division and decorative moldings) matching the original windows, according to the available information on the original windows. Newly planned windows are characterized by a heat transfer coefficient of  $1.5\text{W}/\text{m}^2\text{K}$ , in accordance with the Rulebook [5]. The dismantling of the existing as well as the installation of new windows is planned on the inside of the building, so as to reduce the risk of damage to the facade, that would require additional work.

- Replacing existing roof windows with the same type windows with better thermal performance. Disassembly and reassembly are planned from the inside with all the necessary cladding according to the type of cover. Glazing is with laminated inner and tempered outer glass  $U_w = 1.5\text{W}/\text{m}^2\text{K}$ .

- Thermal insulation of the courtyard facade by placing a 10 cm thick stone wool layer over the existing facade.
- Thermal insulation of the courtyard facade overhangs by placing a layer of stone wool 20 cm thick and a final layer of cement mortar on the rabbit net.
- Thermal insulation of slabs towards the attic space was done by installing a layer of 20 cm stone wool with appropriate protective layers (steam dams, protective foils) in accordance with the requirements of building physics.
- Thermal insulation of pitched roof above the attic office space was performed by adding a thermal insulation layer of 24 cm of stone wool between the existing rafters.

- Insulating the street facade was by installing a thermal insulation layer of 10 cm of stone wool on the inside of the facade wall, due to the limitations issued by the Institute for the Protection of Cultural Monuments of the City of Belgrade.
