GEOTECHNICAL CHARACTERISTICS OF TERRAIN AND PROPOSAL FOR SANATION MEASURES OF LANDSLIDES SULJENDICI, MUNICIPALITY SREBRENİK

Đurić Neđo¹, Imširpašić Kenan², Hadžiosmanović Alma², Đujić Anđa¹

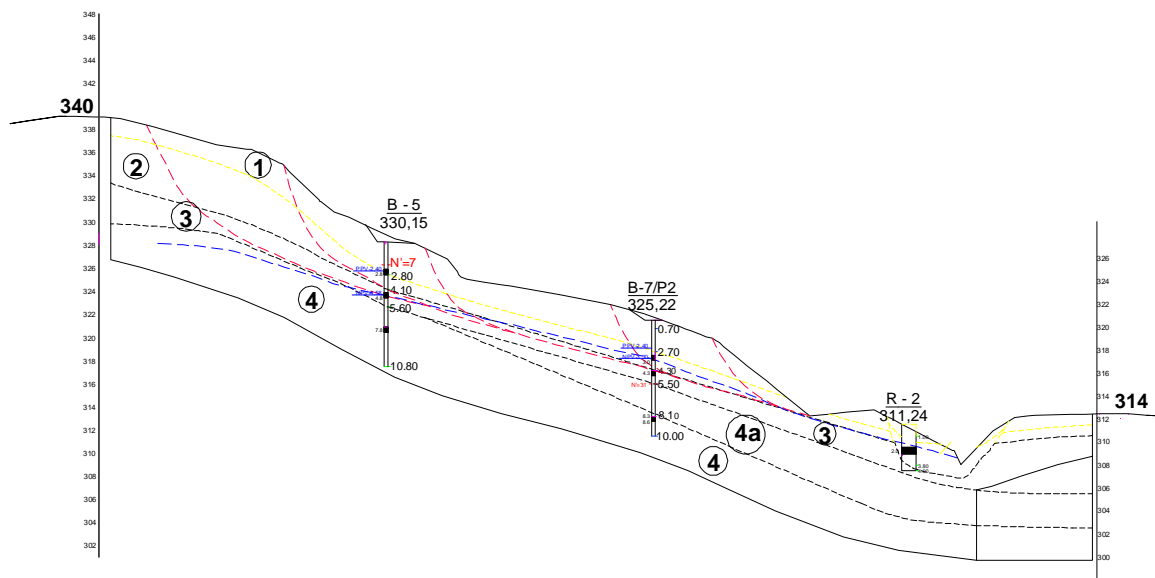
The area of landslide is build of clay sediments which observed in the vertical profile can be classified as colluvial diluvial sediments, layer 1, below which are reddish sandy silty clays with tiny fragments of rocks, layer 2, figure 2. Below these lie tuffites clays, layer 3, which are often interlayered with reddish and misty gray clays. Substrate of the terrain consists of degraded sandstones and conglomerates and clayey gravels and sands, layer 4. As part of the substrate at the bottom of landslide are allocated in the form of lenses, plastic sandy clays with fragments of rocks and gravel pebbles [4].

Figure 2. Engineering geological profile of terrain on landslide
 1, clayey sediments, 2, silty - sandy clay, 3, tuffites clay,
 4, sandstones and conglomerates, 4a, sandy clay

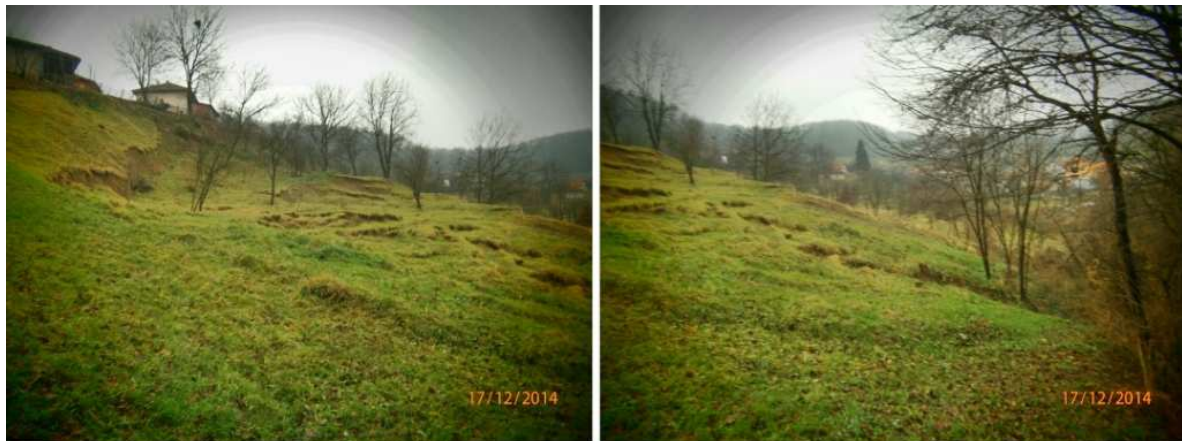
The biggest devastation of the terrain occurred in the central and eastern part of the slope ie at the bottom of residential buildings. Frontal scar is formed in the immediate vicinity of objects. The height difference between objects and beginning of sliding is around 2,0 – 3,0 m, and minimal distance in the horizontal direction is about 10 m, figure 3. The scar continually extends in the length of about 45 m, direction east - west. The height is about 1.0 m on the western side, in the area of facilities is about 2.0 - 3.0 m, while on the eastern side is lost on the local ridge between the the researched and neighboring slope. In the zone of the borehole B - 8 / P1 branches and a longer arm can be discerned all the way to the far east side of slope. Along scar length are registered washings, and in bottom part of the scar are present changes of small surfaces that are important for further development of sliding process, figure 3 .

Figure 3. Frontal scar and bottom part of slide

Next sliding scar also spreads in direction east – west but its contours are not clearly expressed along the entire length. In the hinterland, borehole B – 4 height is about 1,0 m and in the immediate vicinity of borehole is formed a secondary scar height to 0,5 m. Further to the bottom part of slope, in the zone of borehole B – 7/P2, is formed one more scar whose contours are clearly visible on the eastern part of the slope, but does not affect the middle part.

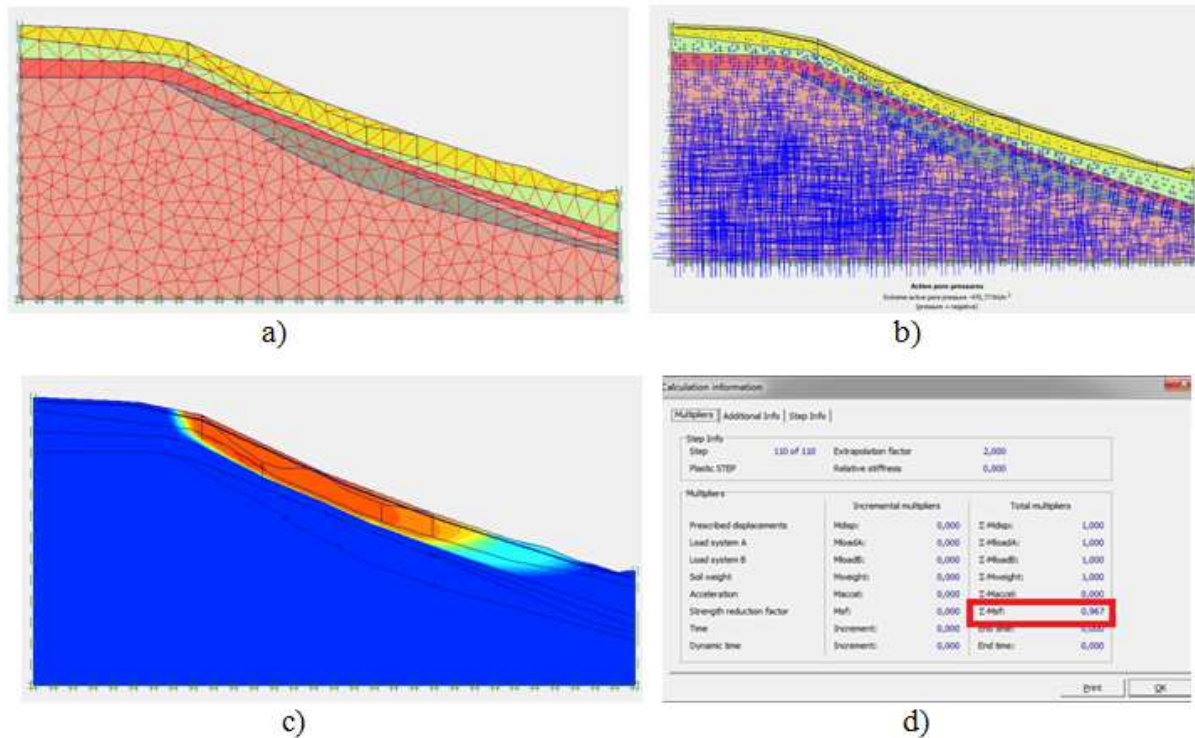
Figure 4. Characteristic profile 2, stability analyzes

On profiles 1, 2 and 3 were made geotechnical models with selected parameters of soil whereby all layers of soil were completely saturated with water up to the line of terrain. For those conditions were obtained safety factors $M_{sf} < 1$ for critical sliding plane made with method c/φ reduction, which

indicates that the soil is not stable. The same confirm reality on the ground. Characteristical profile 2, is shown on figure 4.

c) the potential sliding plane with a safety factor $MSF = 0.967$, d) part of the listing calculation

Proposals for sanitation measures relate to the controlled drainage - decreasing level of groundwater of entire site that is affected by sliding [9,12,13]. Drains will be brought from the zone of residential buildings to the stream at the bottom of the slope. Filling of drains is of crushed stone, to a depth of overtake of non moving parts of the terrain. Number and spatial position of drains should be placed in accordance with the calculation evidence of slope stability.

To stabilize the terrain is necessary to regulate the stream bed in the bottom of the slope, in the way that bottom part of the slope is ensured from eroding during the torrential waters.

Surface of sanitized slope regulate in terms of its inclination in order to achieve conditions for its quick and easy surface draining. Sanation works perform during the dry season, since the tuffites clays of layer 3 are expansive when soaked with water.
