Review paper
UDC 625.11:656.222.4.01
DOI: 10.7251/afts.2018.1018.009D
COBISS.RS-ID 7322648

RESEARCH METHODOLOGY OF RAILWAY ROUTE DOBOJ – ZENICA, SECTION km 103+500 – MAGLAJ

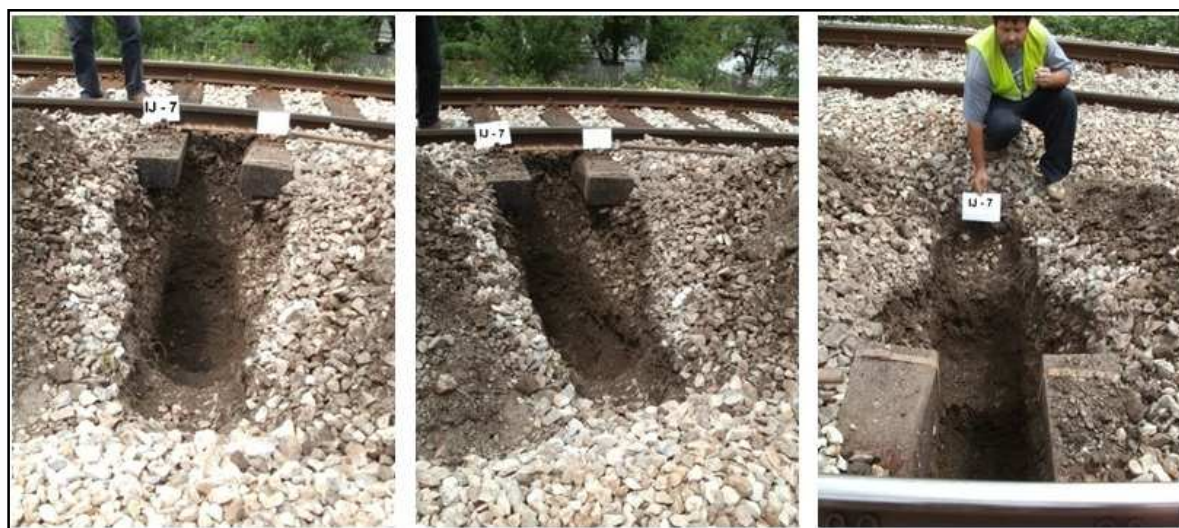
Figure 2a. Characteristic example of trench IJ – 7 on chainage km 105+450,00

Trenches were in detail mapped, photographed, figure 2a, and also were taken disturbed and undisturbed samples covered with the same material. Based on terrain mapping, results of laboratory tests, profiles of all trenches were made, figure 2b, as well as transverse profiles of the terrain along the route of the railroad.

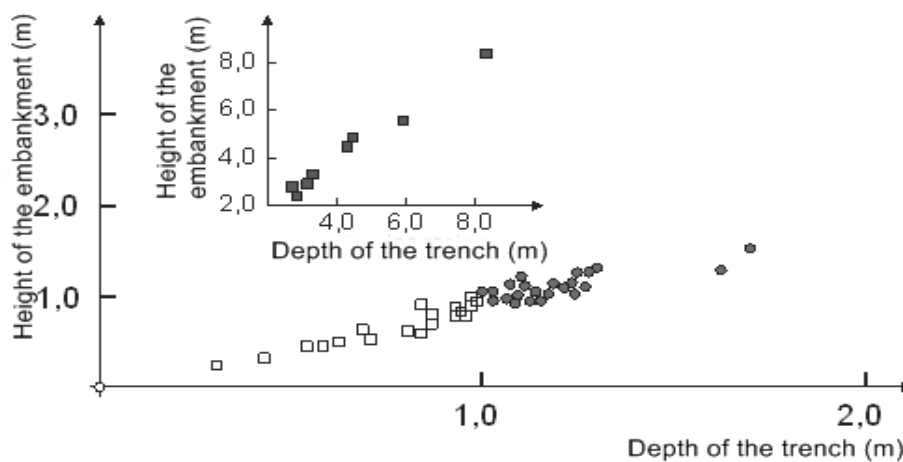
Figure 3. Chart of relations of height of embankment and depth of trenches along the railroad

Exploratory trenches were carried out along the entire route mostly at a depth of 0.7 – 1.5 m, figure 3. If we keep in mind that the depth of the trench was 0.2 - 0.3 m below the embankment, it can be concluded that the embankment thickness is ranging from 0.5 – 1.2 m. It is important to emphasize that the right track on the same chainages is characterized by deeper embankment, because the regulations from 1978, were more demanding.
