Professional paper

LANDSLIDE ON LOCATION OF WATER SOURCE STUDENAC NEAR BIJELJINA, REPUBLIKA SRPSKA

Đurić Nedo¹, Perisić Milan¹, Đurić Dijana¹

¹*Technical Institute Bijeljina, E.mail: tehnicki@tehnicki-institut.com*

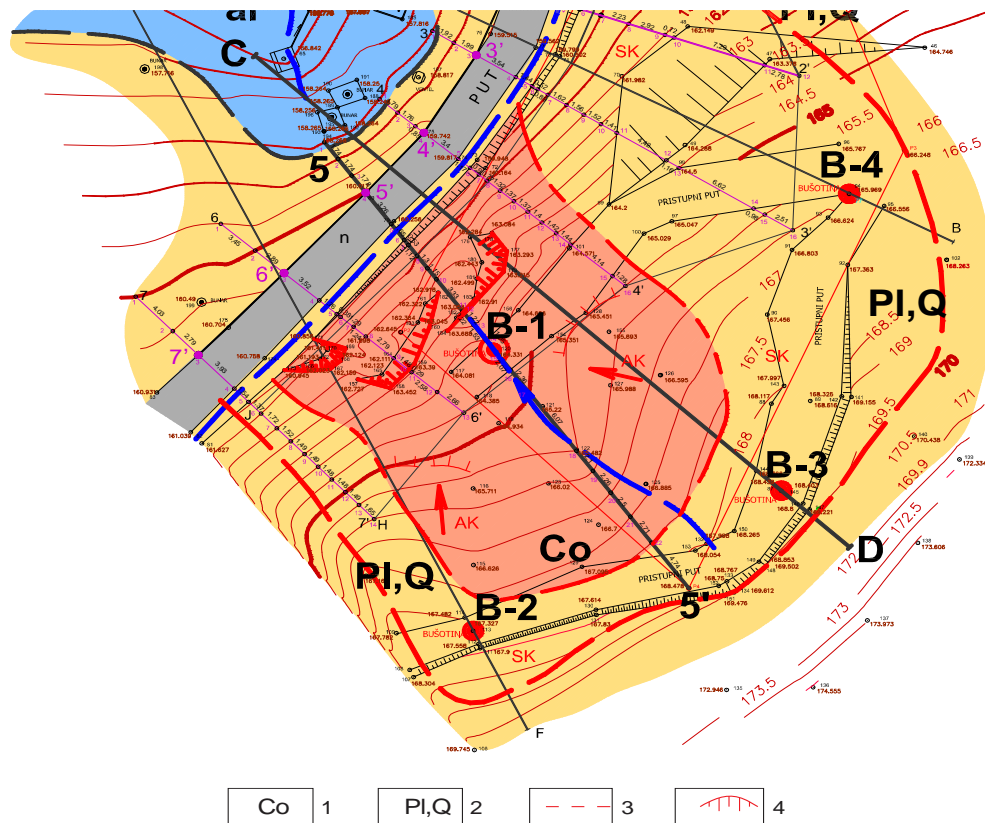
Researched valley and the whole wider area is composed of Plio-Pleistocene-Quaternary sediments (Pl,Q) picture 1. Grey-brown and grey-yellow clays that are extremely rich in calcareous concretions, gravelly sand layers and interbeds that make integral part of Plio-Pleistocene sediments represent them. The depth of research works up to 10 m does not capture their maximum depth.

Picture 1. Engineering-geological map of the studied site
Colluvial sediments, 2. Pliocene-Quaternary sediments, 3. Landslide ridge, 4. Landslide scars

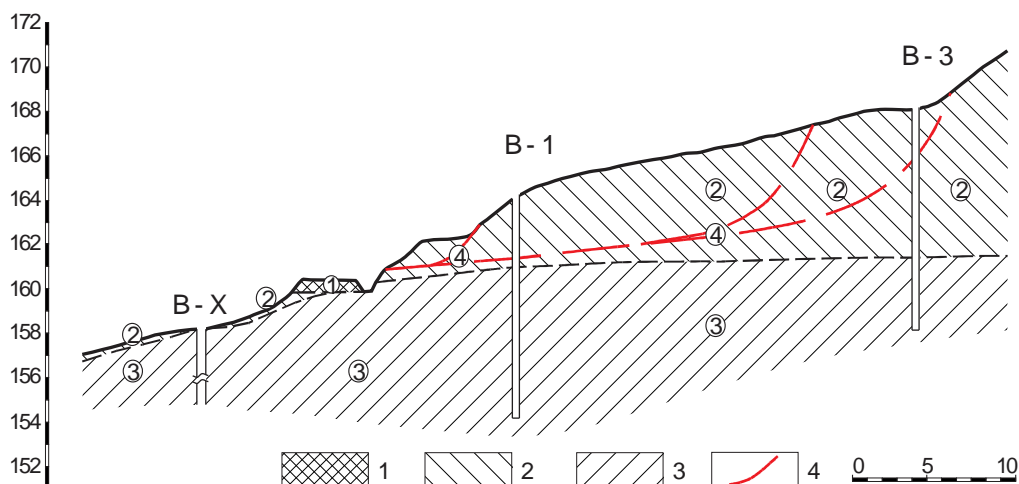
Composition of the field at the respective location is made of two environments separated as plastic medium presented by clays and bulk medium made of gravels and less of sands, picture 2.

Picture 2 Geotechnical site profile C-D
 1. Technogenic sediments, 2. Silty clay sediments (Cl, Cl-CH, CH),
 3. Gravel sediments (GF), 4. Sliding plane

Sliding plane was formed at depth of 2,5 to 4 m, depending on site morphology, in clay of high plasticity (CG groups). The inclination of sliding plane in the forehead scar area is steep and further towards the toe it is very mild, up to 7° . Further landslide characteristics are as follows:

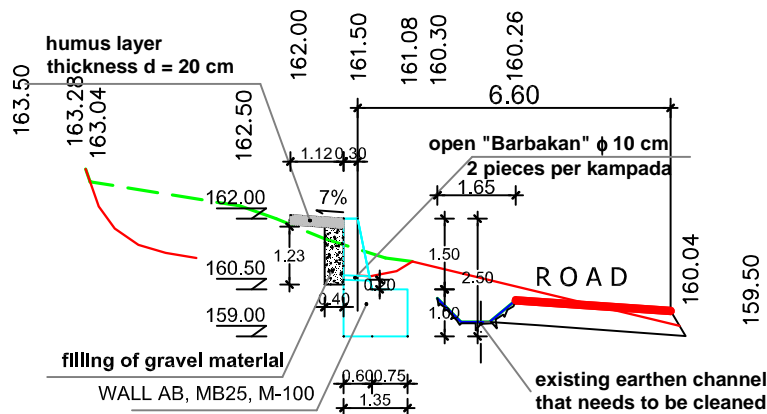
Analysis of the slope stability was done for the terrain conditions shown at the section 5 – 5' where embankment beds, clay and sandy gravel beds are present. Clays are the type CH and CI, fractured in the surface part and they can accept water that erodes their surfaces. Depth of the bed is from 2,0 to 8,0 m. Below the clay layer there is a substrate made of gravel soil GC. This layer is very resistant and suitable for foundation retaining structures. During the hydrologic maximum, it is possible that the level of underground water rises to the clay layer and then it presses and deforms the lower side.

Picture 4. Transverse profile of the field and the retaining wall 5 – 5'

In order to prevent restorative works to cause new sliding and slope instability their dynamic was determined. Firstly, on open canal without lining was constructed to accept surface water at the slope above the retaining wall. Then excavation works and concreting of retaining wall were performed in planes of 4 m until the retaining wall was completely finished.

The stability analysis was conducted for natural conditions including presence of underground water where obtained $F_s = 1,02$, and applying the restorative measure using AB retaining wall, which increases the safety factor to $F_s = 1,41$. For the purpose of the rehabilitation, two restorative measures were applied and that is: reinforced AB retaining wall made of concrete MB 25 based in sandy gravel layer and construction of the open perimeter canal above the retaining wall in order to collect and drain surface water.
