## LANDSLIDES ON THE ROADS OF THE NORTHERN PART OF THE REPUBLIC OF SRPSKA AS A RESULT OF ELEMENTAL OR ANTHROPOGENIC PROCESSES

Đurić Neđo,<sup>1</sup> Đurić Dijana<sup>2</sup><sup>1</sup>Technical Institute Bijeljina, Starine Novaka street nm, Republic of Srpska, Bosnia and Herzegovina, e.mail, nedjo@tehnicki-institut.com<sup>2</sup>Faculty of Civil Engineering Subotica, University of Novi Sad, Serbia

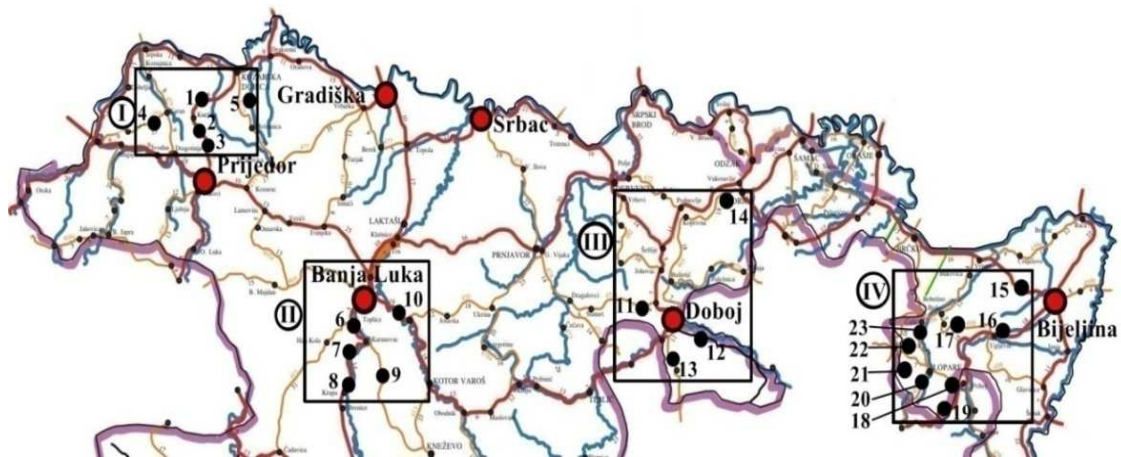
Figure 1. The area affected by increased rainfall and landslides on significant roads, during May, 2014.

I. Western part–area of Prijedor, II. Southern part –area of Banja Luka,  
III. Southern part–area of Doboј, IV. Eastern part – area of Bijeljina

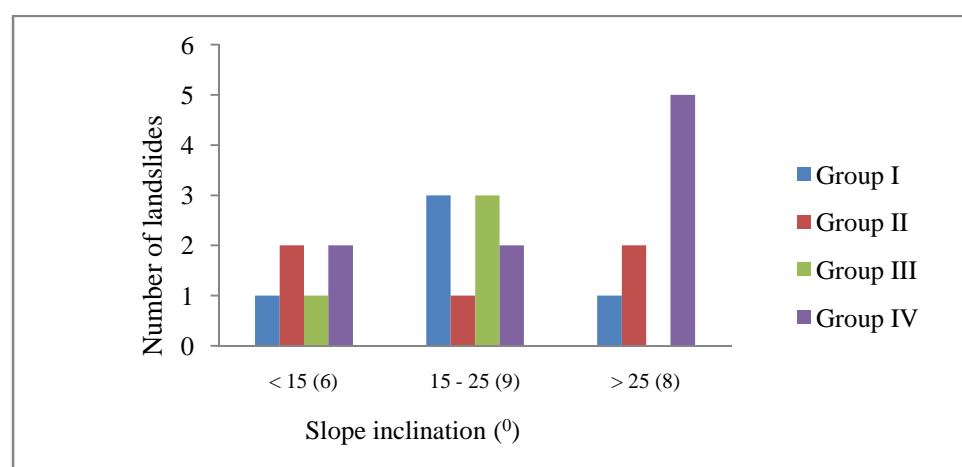
23 characteristic landslides were analyzed and classified into four groups according to their area of origin. Each landslide is marked with a number from 1 - 23, and their spatial position is shown in figure 1. Surveyed by the selected groups from I - IV, the slope inclinations on which the landslides formed values from 9,2 - 28,4°, table 1. Selected landslides are divided into three categories, where it can be seen that the landslides are more present on slopes with higher inclinations. They classify to the second and third category with inclinations from 15 -25° and > 25°, figure 3.

Figure 3. Landslide chart according to inclination of slopes by selected groups I - IV

The slope inclinations at the locations of the explored landslides range from 9,2 - 28,7° and they are classified into three categories, figure 3. Observed by the locations of selected landslide groups from I

- IV, the highest number of landslides occur at the slope with inclination of  $> 20^{\circ}$  in group IV. The terrain in this area is morphologically very developed and belongs to the mountainous part. In general, the analyzed landslides are related to slope inclinations that are often found in the literature data.

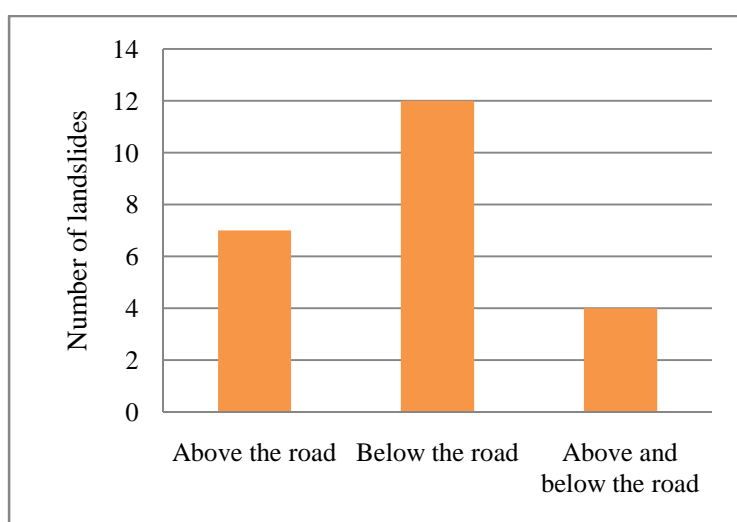
The formation of landslides on the roads is different from the fact that they occurred above the road, below the road, and one section of landslide cut the road completely because they were formed above and below the road, figure 4. By examining the above mentioned landslides, it was found that there was insufficient level of terrain exploration along the road route, especially in the part of conditionally stable or unstable zones.

Figure 4. Spatial position of landslides on the roads

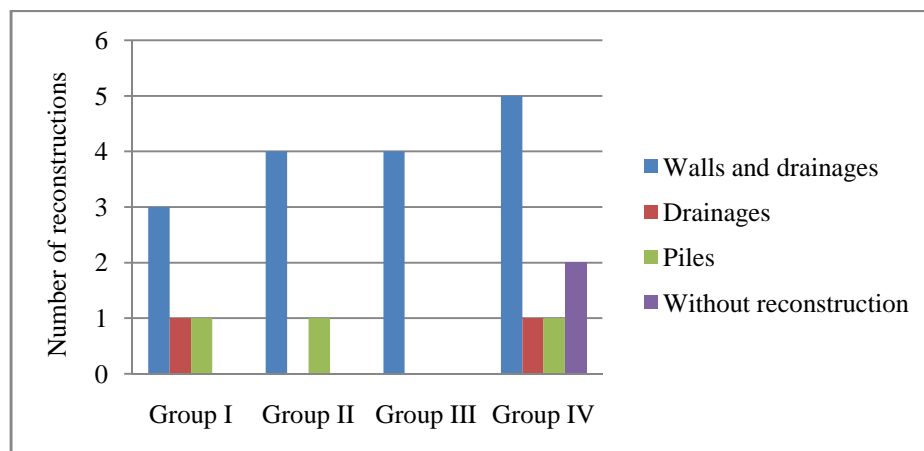
At the same time, with the inspection of the landslide characteristics, the slope reconstruction is also considered at the time of construction, that is, the condition of the restoration facilities after the occurrence of landslide. The slopes have been repaired by means of retaining walls, drainages, rarely with piles or by combination of mentioned objects, figure 6. All types of repairs are damaged,

especially retaining walls and piles. The construction of some retaining walls is not damaged, but it is moved together with the rock mass. It is evident that they were not founded deep enough in the hard formation rock, but instead they remained in the surface area. Some landslides had even earlier damages that were repaired, and now damaged again, so that various types of reconstructions can be observed at different periods of time. Usually these are retaining walls or walls and piles.

Figure 6. Overview of the types of reconstruction of slopes by selected groups I - IV
