Review paper

LANDSLIDE REMEDIATION ON THE SCARP ABOVE THE LEVEL, ROAD M-17, SECTION: 007, TOPČIĆ POLJE – LAŠVA

Talić Zlatan¹, Cerić Dženita²¹*InfraPlan d.o.o., Sarajevo, Bosnia and Herzegovina, e-mail, zlatan.talic@infraplan.ba*²*Faculty of Technical Engineering, Bihać, Bosnia and Herzegovina*

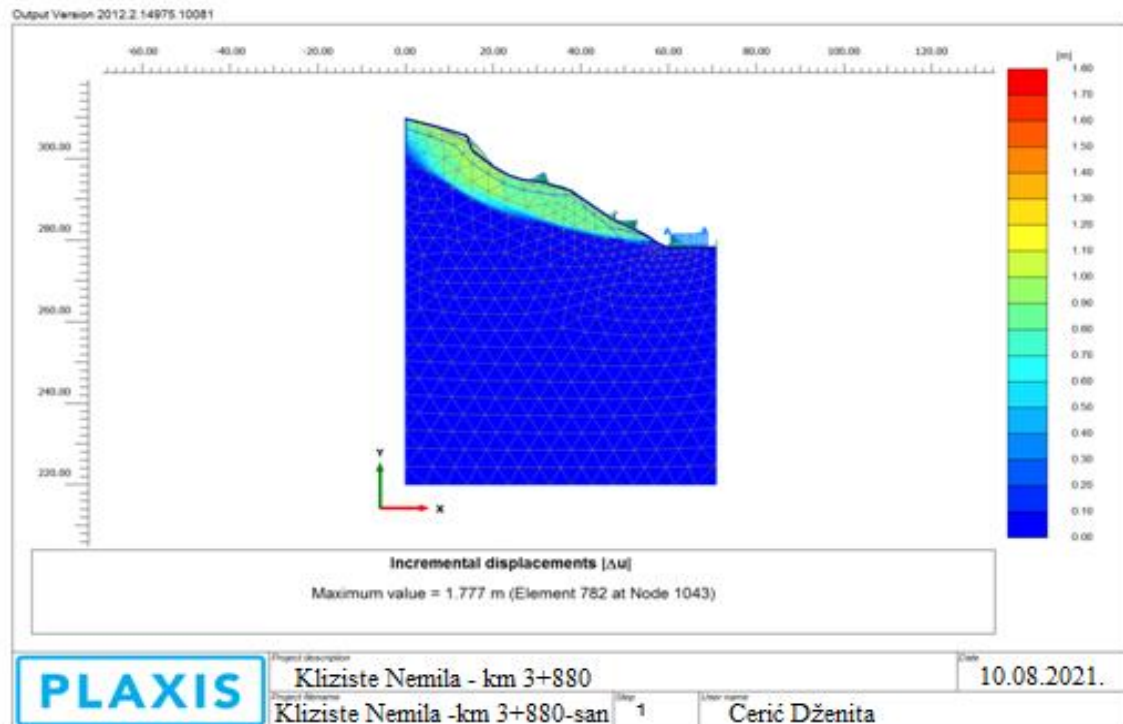
The calculation was carried out on the most critical cross-sectional profile. It is assumed that the landslide is in a state of boundary equilibrium, i.e., that the safety factor is $F_s = 1,000$. Figure 1 shows the most critical sliding surface in the natural state, obtained by calculation based on field and laboratory exploration, engineering geological determination and classification of investigation bore holes, as well as the results of feedback analysis. The following calculated soil parameters for selected geotechnical environments were determined [3].

- for cover materials of geotechnical environment GS 1: deformation modulus $E_s = 12$ MPa; bulk density $\gamma = 22$ kN/m³; internal friction angle $\varphi = 27^\circ$ and cohesion = 30 kPa,
- for materials of geotechnical environment GS 2: deformation modulus of rock mass $E_s = 20$ MPa; bulk density $\gamma = 22$ kN/m³; internal friction angle $\varphi = 32^\circ$; cohesion = 25 kPa.

Figure 1. Calculation of slope stability for natural condition $F_s = 1,000$ [3]

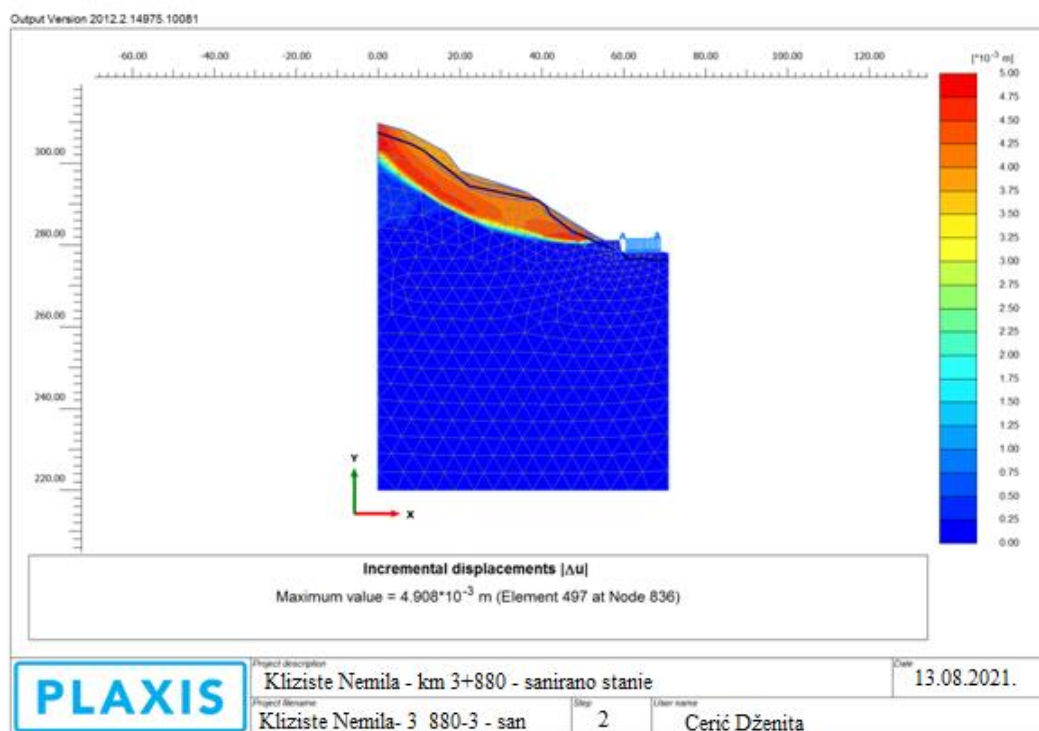
In the second phase of the calculation, the analysis of the remediated slope was performed, and the safety coefficient $F_s = 1.257$ was obtained. Figure 2 shows the most critical sliding surface of the remediated slope [3].

Figure 2. Calculation of slope stability for repaired condition $F_s = 1,257$ [3]

- construction of a b. 75,0 m long wall above the road,
- construction of drainage behind the wall,
- mitigation of the slope at the front of the landslide to a slope of 1: 1,5,
- construction of "Y" drainage through the body of the landslide, whose arms extend above the front of the landslide,
- construction a stone throw in the middle part of the landslide,
- cleaning of existing culverts and gutters.

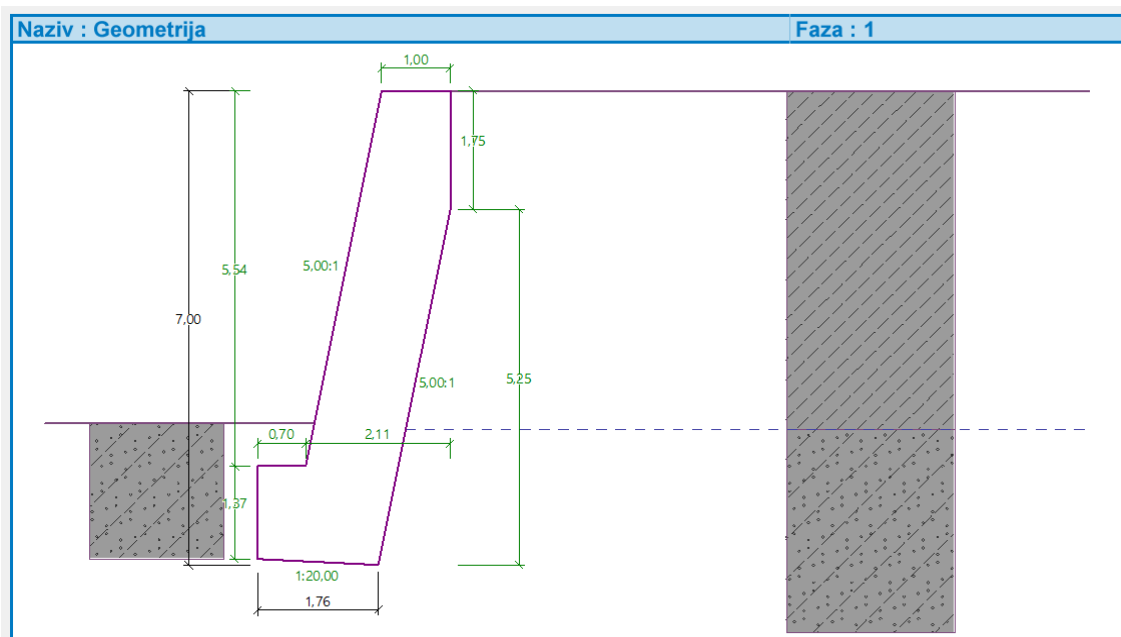
Figure 3. The dimensions of the retaining wall

The dimensions of the retaining wall are given in Figure 3. [3]

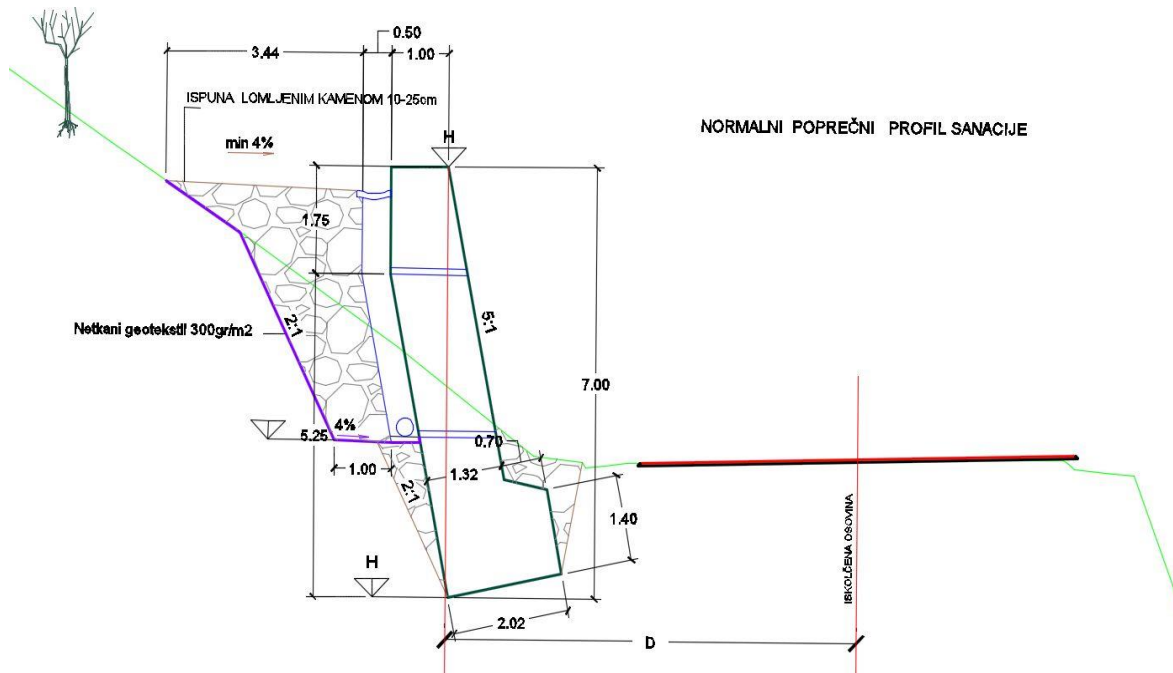
Figure 4. Normal transverse remediation profile

1. Retaining wall in the central part with length of 50,00 m and height of $H = 7,00$ m.
2. Primary drainage collector - collects and drains all drainage water further from the landslide zone.
3. Construction of transverse drainages.
4. Placing a stone throw above the retaining wall – securing the slope.
5. Manholes – used for collecting, cleaning and controlling groundwater overflow.
6. Drainage of water to the existing culvert $\phi 1,00$ m.
7. Construction of gabion walls in order to prevent scarp shelling on P.19 (km 3 + 961,00).

The solutions are shown in Figure 4 for normal transverse remediation profile.
