Analysis of Traffic Accidents Caused by Overcome and Left Turn Actions in a Situation When the Vehicles Have Been Moved from the Face of the Place, and There Are no Tracks Found on the Road - A Case Study

EXAMPLE OF THE ANALYSIS OF A TRAFFIC ACCIDENT WITH A CHARACTERISTIC PROBLEM

The paper presents an example of the expertise of a traffic accident that occurred while overtaking and turning left, in which the stopping positions of the vehicle after the collision are not known, nor were any traces of the accident found on the spot.

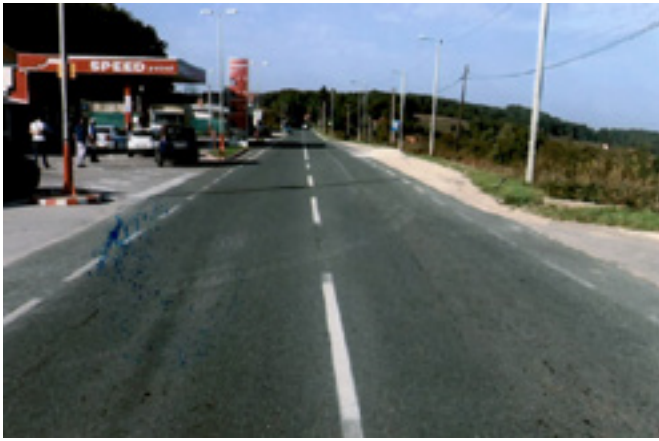
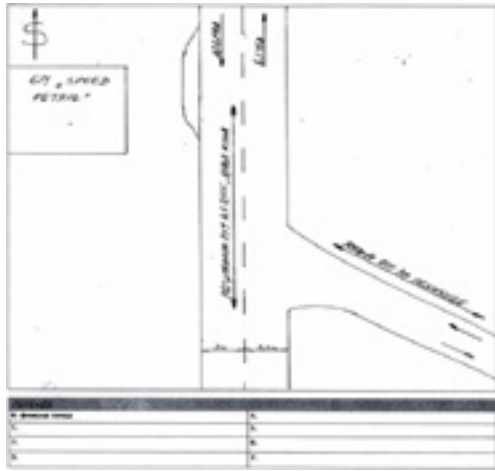
In Figure 1a. and 1b. a picture of the scene of the accident from the investigative photo documentation prepared by the PS for BS Banja Luka, as well as a sketch of the scene, was shown.

Figure 1. a) Appearance of the scene of the accident from investigative photo documentation b) sketch of the scene of the accident

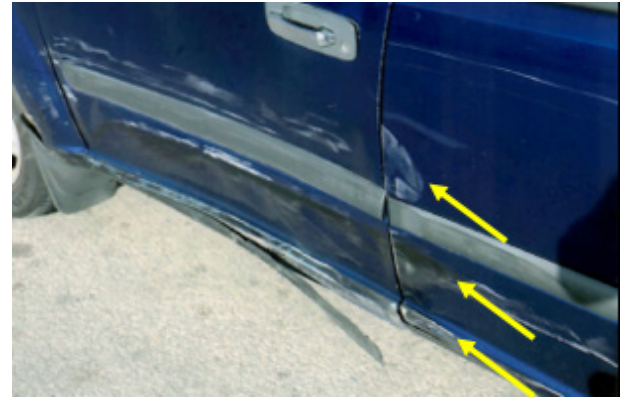
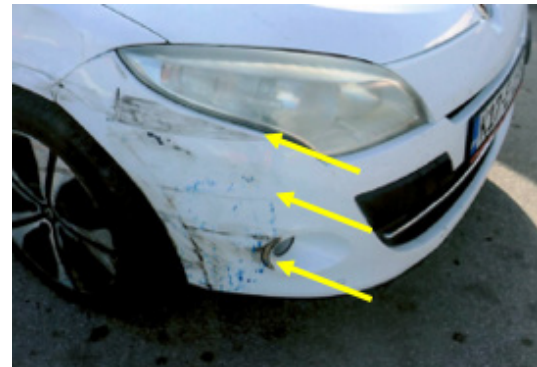
The rear bumper, rear left side panel, rear left wheel, rear left door, front left door, left sill, front left fender and front bumper were damaged on the passenger car “Nissan X-Trail”. The front bumper, front right headlight, front right fender, front right wheel, front right door, rear right door, rear right side panel and rear right wheel were damaged on the passenger car “Renault Megane”.

The analysis of the damage caused to the vehicles shows that the impact force on the passenger car “Nissan X-Trail” acted diagonally, from the first half of the rear

left door and the left “B” pillar to the front right headlight. On the passenger car “Renault Megane”, the collision force acted along the vehicle, from the front right to the rear left corner, over the central part of the front right fender, the right wheel, the front and rear right doors.

Figure 2. a) damage to the passenger car “Nissan X-Trail” b) damage to the passenger car “Renault Megane”

A detailed and comparative analysis of the previously described damage to the vehicles and the direction of impact of the impact force, and bearing in mind their directions of movement immediately before the collision established in the Report of the investigation, it follows that the collision occurred with the front, far right part of the front bumper of the passenger car “Renault Megane” with the left by the side part of the “Nissan X-Trail” passenger car, in the middle of the rear left door and the left “B” pillar. At the time of the collision, the longitudinal axes of the vehicle overlapped each other at an angle of about 20.5°.
