Mato Uljarević, mato.uljarevic@aggf.unibl.org, Faculty of Architecture, Civil Engineering and Geodesy, University of Banja Luka

Ljubomir Palikuća, ljubomir.palikuca@yahoo.com, Integral Inženjering a.d. Laktaši

RELIABILITY OF THE RISK ANALYSIS IN MAKING DECISIONS ABOUT VARIANT SOLUTIONS ACCEPTABILITY OF THE PLANNED ROAD

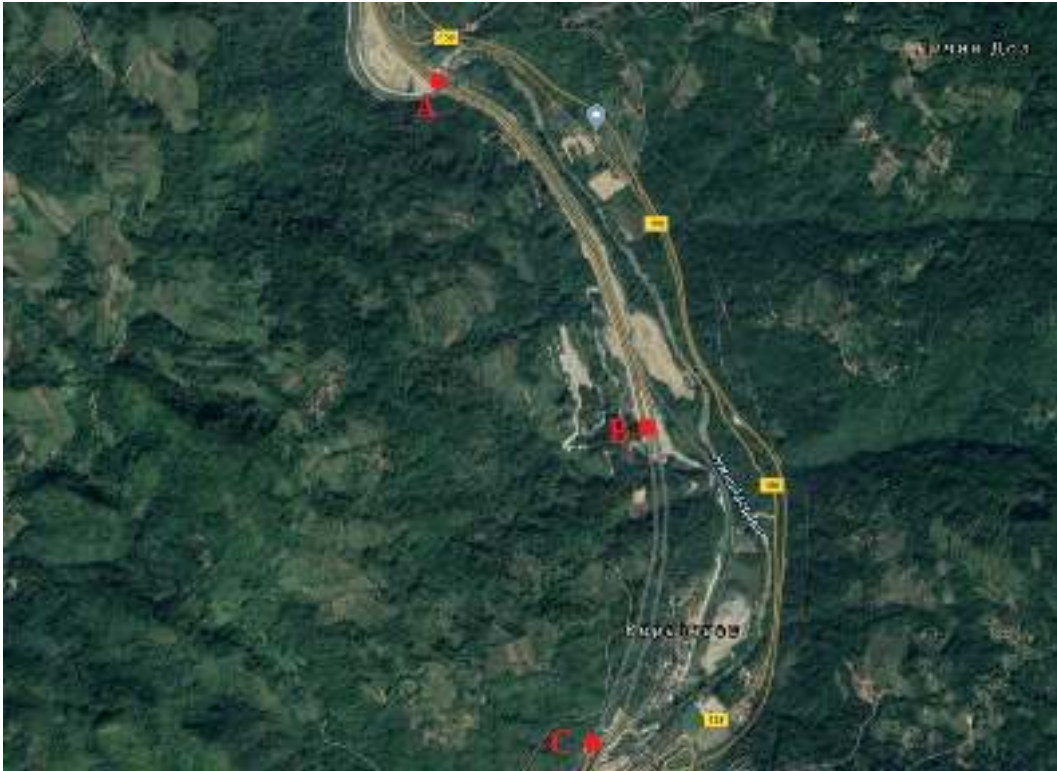
On the figure 1. it has been shown subject road location. From point A to the point B it has been constructed a road in the cut in length of around ca. 1300 m. Another part from point B to the point C in length of ca. 1000 m a tunnel has been constructed (a variant solution constructed).

Figure 1 *The subject road*

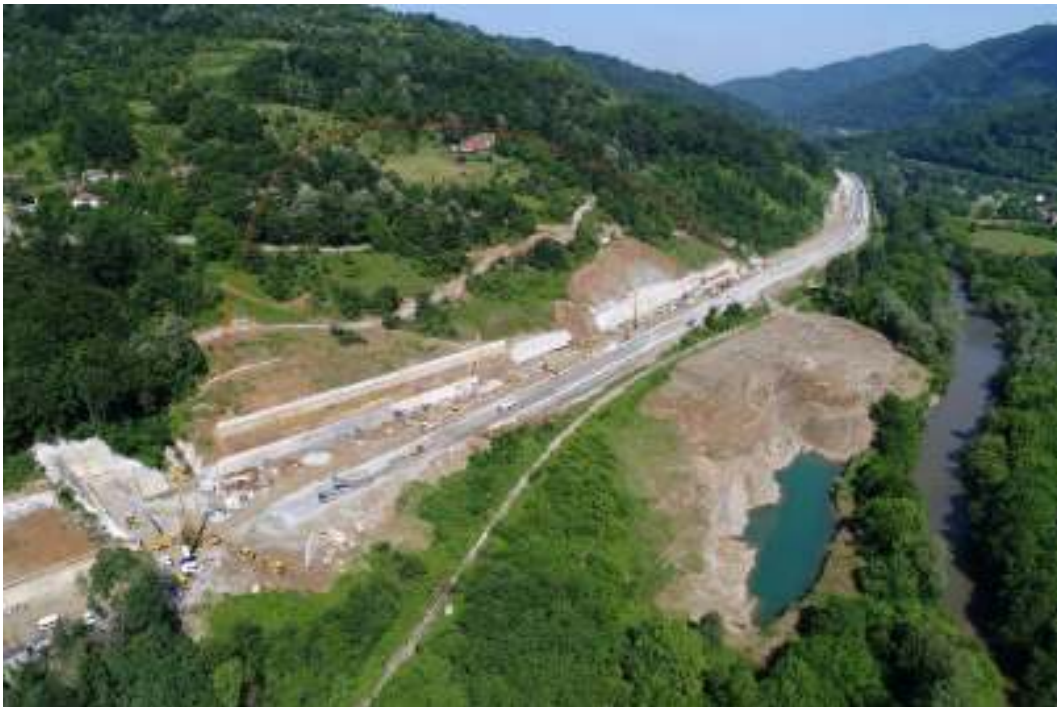
Realization of this variant solution is constructed through the phases. Based on previously collected data, designing has begun and afterwards and performing. Immediately after works completion it has come to the stability disruption of conditionally stable slope and landslide activation just in front of the tunnel (Figure 2). Formed landslide was threatening the highway route, performed slopes and support structures but also structures beyond expropriation on the slope.

Figure 2 *Formed landslide on the slope 2*

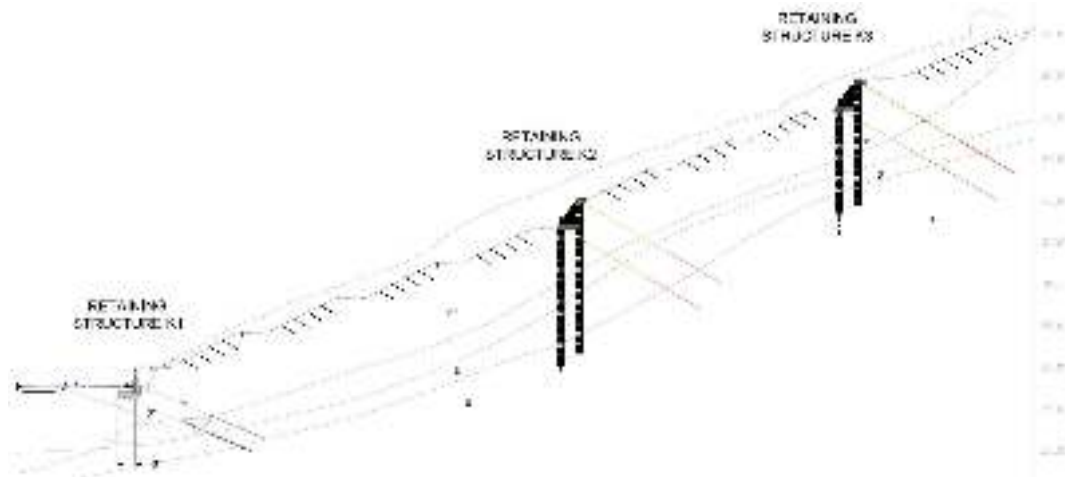
By project task is required that rehabilitation solution for land slide and slope stabilization should be performed in phases with two supporting structures from piles K1 and K2. During structure K1 performing, which has a role to protect directly highway hull, certain sliding body activities have been registered, and they have been interpreted by activating an even more unfavorable slip mechanism compared to the solution model. Considering that situation on the ground has been changed, beside almost designed supporting structures K1 and K2, another supporting structure was designed from pile K3 (Figure 3).

Figure 3 Retaining structure

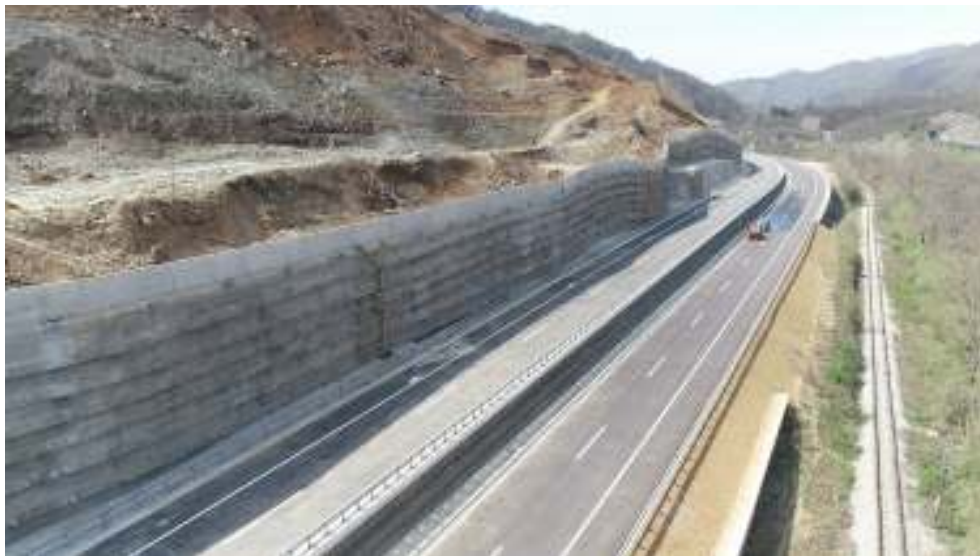
In the meantime, additional geotechnical fieldwork, exploratory works and exploratory wells were carried out in which inclinometers and piezometers were installed, as well as an appropriate laboratory tests which were the basis for study which has served like one of the substrates to access the rehabilitation and stabilization process subject slope. Based on the results obtained geotechnical results, engineering-geological ground mapping and defined spread of the colluvial process on the slope, registered landslides elements (scars, jumps, belly, crack sand similar), it has been defined mechanism of the process which has served like basis for static analysis and slope stabilization problem solving.[4:1-2] Activities listed have caused prolongations of the completion deadlines and work price increase. Previous testing and exploring were not enough good analyzed hazard occurrence on subject location, and therefore the risk could not be analyzed, so it was not evaluated that sliding will occur. Parallel with work performing on the slope 2, the works on the slope 1 are performing also. It is about the same problem, so by original design solutions (supporting structure from micro piles with geotechnical anchors) it could not get the permanently solution. Unloading of the work and reinforcement of the slope with protective nets and anchors is carried out (Figure 4).

Figure 4 Formed landslide on the slope 1

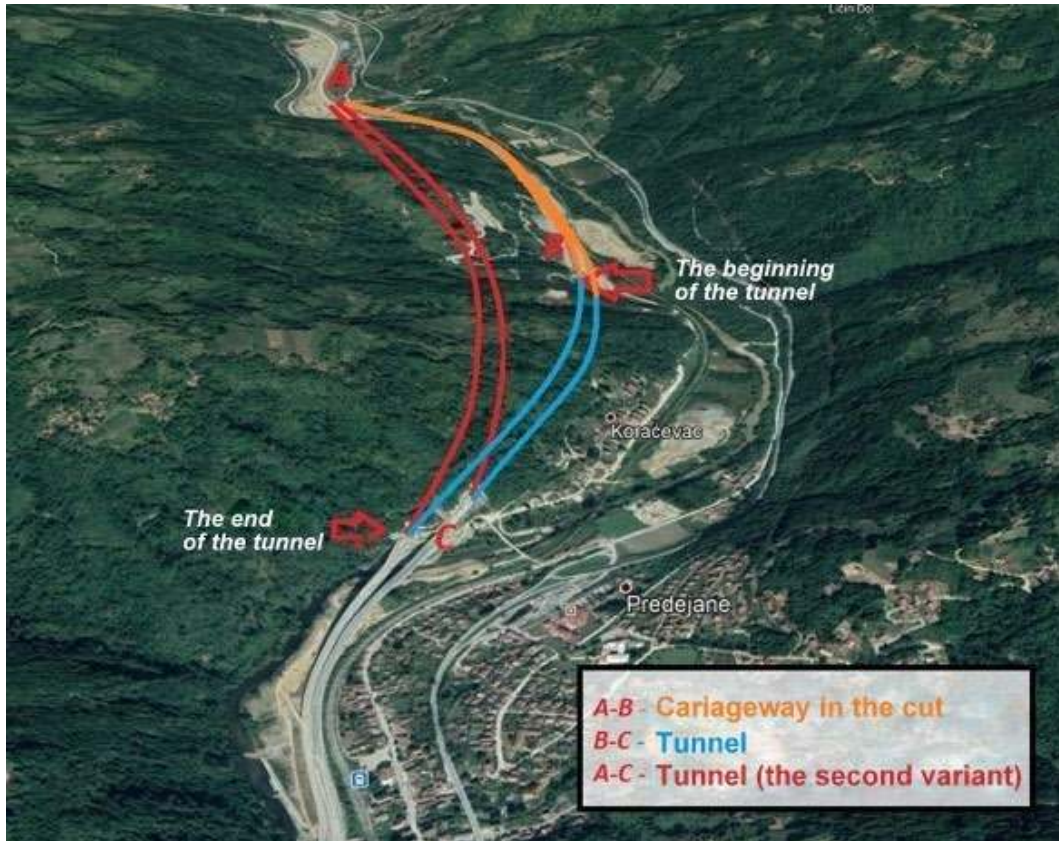
If at the beginning there were complete information about geotechnical substrate, probably it would be considered other variant solutions. It is possible that design solution, in the goal of optimality, could require also the road route correction (by situation and by height). Probably and final defined solution would be optimal, but that done in the beginning phase, in the high measure would eliminate additional costs due to the work extension, deadlock in design, and finally, direct income loss from previous road commissioning [2:202-203]. By analyzing previous listed problems related for wrong assessment and risk analysis, a conclusion is imposed that all happenings could be avoided by tunnel tube prolongation from the point A to the point C (Figure 5).

Figure 5 Tunnel tube extension

Comparing two variants, there is conclusion that insufficient research and insufficient analysis, but also bad substrate preparation for designed documentation, inevitably leads to the performing works price increases and deadlines completion prolongation. Constructed tunnel is about one kilometer long (B-C). Constructed tunnel construction value along one meter was ca. 16 800 euros. Landslides rehabilitation construction value on the slope 2 is ca. 89 000 euros. Tunnel tube prolongation is about 1300 m. In the table 1 there were shown total structures lengths, also as performing time and costs. Listed data analysis gives the conclusion that the tunnel construction on the subject location would be more cost effective than slope rehabilitation, with less period of construction.
