Review paper
UDC: 551.435.62:624.131.537
DOI: 10.7251/afts.2014.0611.0250
COBISS.RS-ID 4571672

EXAMPLES OF LANDSLIDES IN THE FEDERATION OF BOSNIA AND HERZEGOVINA WITH THE ANALYSIS OF THE CAUSES OF THEIR ACTIVATION

Operta Mevlida¹, Golijanin Jelena², Čatović Amra³

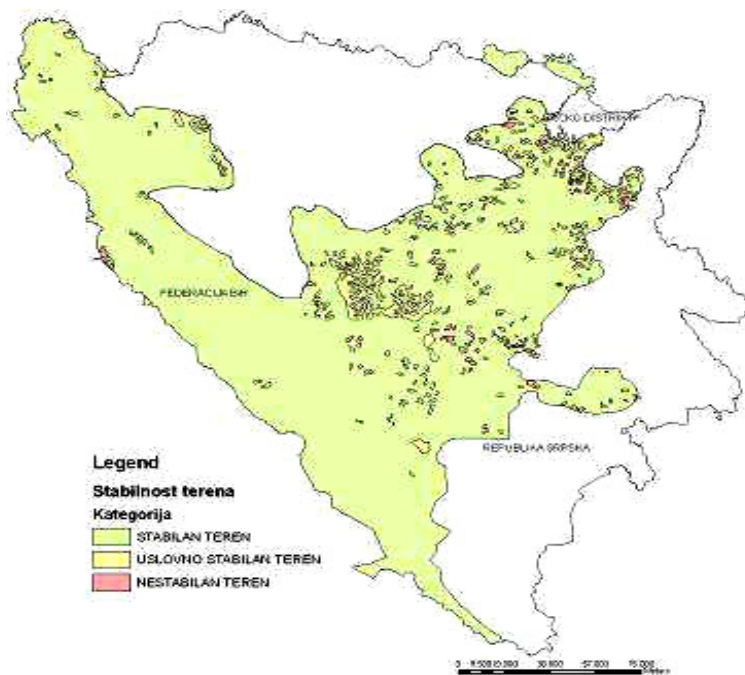
Figure 1 shows the zone of stable, unstable and conditionally stable terrain of the Federation of Bosnia and Herzegovina [1]. That is defined as:

- Unstable terrain, high hazard and conditional probabilities of landslide formation $> 10.67\%$
- Conditionally stable terrain, medium hazard and conditional probabilities of landslide formation $3.56 - 10.67\%$
- Stable terrain, low hazard, conditional probability of landslide formation $< 3.56\%$.

Figure 1 Ground stability in the Federation of Bosnia and Herzegovina

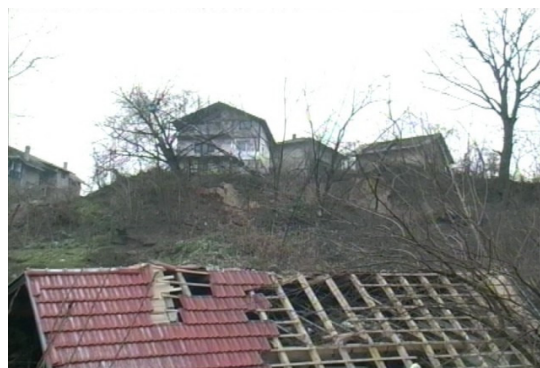
The depth of the landslide is 10-12 meters and is related to the depth of burial clay layer that lies beneath the sand, figure 2.

Figure 2 Landslide "Crvene njive" in Tuzla, Bosnia and Herzegovina.

In the western part of the Tuzla municipality in the district of "Crvene Njive" is a broad cam form built mainly of quartz sand and clay, with the proviso that the sand until 1963. was exploited for the purposes of infilling pit mines Moluhe whose exploitation was completed in 1963. High depression with two high and steep slopes that were left unprotected from impact erosion remained after the exploitation of sand. The wider area is located in an area of Sjeverne kreanske coal serie. After examining the existing geological and engineering-geological documentation it was clear that on this site before activating the escarpment, landslidewas not registered. This area has been for more than 40 years exposed to the effects of exogenous processes, so minor crumbling without major instability happend. In the hinterland of Južna kosina a large number of illegally constructed buildings that don't have governed drain of rainwater and wastewater was built, and also greater quantity of garbage was delayed.

After the geophysical investigations, it was found that a fault is formed in the frontal section. Along unfavorably oriented faults and neotectonic cracks within the massif, separation and breakout of sandstone blocks occurred [4].

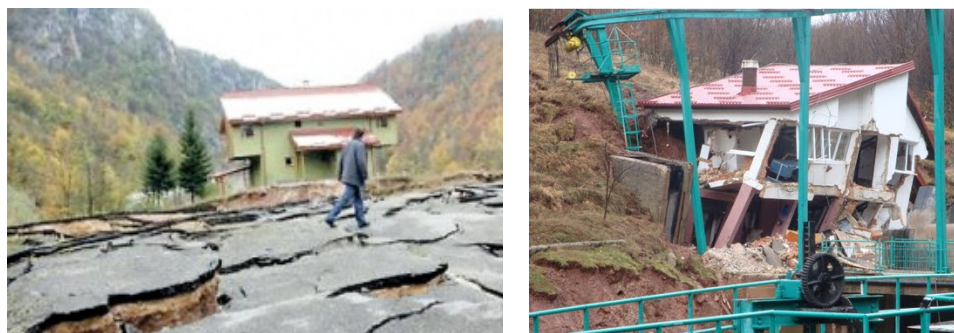
Landslides negatively influence on morphology of surface of area and it can be seen in examples of landslides in Suljaković near Maglaj and Bogatići at Trnovo [5]. One example of impact of landslides on forest vegetation is also landslide in Bogatići at Trnovo, which represents the largest and fastest landslide, figure 3.

Figure 3 Landslide in Bogatići, Municipality Trnovo – Bosnia and Herzegovina

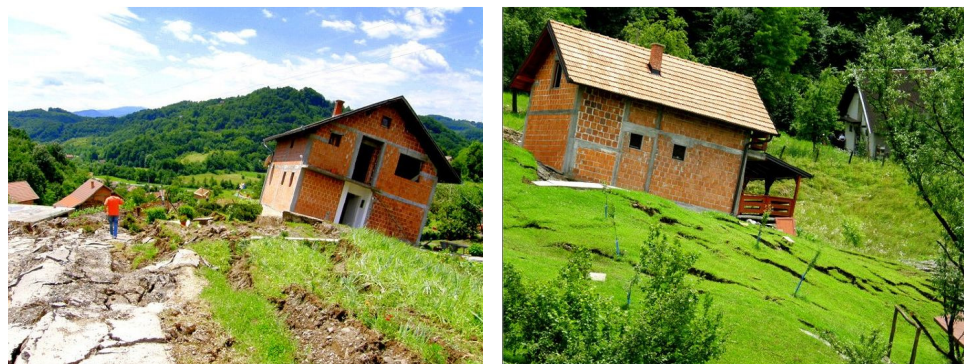
Landslides negatively influence on morphology of surface of area and it can be seen in examples of landslides in Bogatići at Trnovo and also Suljaković near Maglaj [6]. According to the scale and catastrophic consequences, this landslide is one of the largest in BiH. During the construction of the M-17 there was already a landslide, which was then repaired. Landslide is certainly formed after recent rains. During the construction of houses, these were buried streams which are on the left and right sides of landslides. These streams were dragging surface water. Another cause is illegal construction. Cutting the slope at upper side of facilities, including leveling and filling from lower side, resulting imbalance of mass, disturb is natural balance conditions and then worst happens, figure 4.

Figure 4 Demolition of houses in Suljaković, Municipality Maglaj – Bosnia and Herzegovina
