*Review paper*  
*UDC: 726.3(497.113 Subotica)*  
*DOI: 10.7251/afts.2017.0916.035A*  
*COBISS.RS-ID 6437912*

## CHANCE FOR REVIVAL – SYNAGOGUE IN SUBOTICA

### ABSTRACT

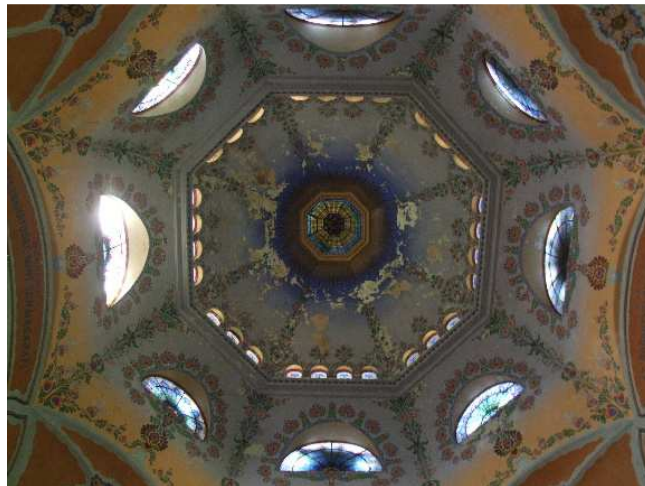
Figure 2. Interior of the synagogue dome displaying damaged layer of paint (Authors photograph from 2016.)

“Standardprojekt”, led by the main engineer László Király, inspected static stability of the interior wire lath dome [3]. In 1988, apart from restoration works on the decoratively painted main dome of the Synagogue, both male and female toilets were built in the cellar area of the Synagogue, below the staircase leading to the gallery. After conclusion of the works, in February of 1989, the building was re-handed over to Subotica “National Theatre – Népszínház”. In the following period, the restoration of the Synagogue ceased once again, yet the efforts to move out the National Theatre from the building became more and more intense. In January 1991, representatives of the Inter-municipal Institute noted in the Synagogue a curtain which was scorched by a thermal accumulation heater. Thermal accumulation heating for the benefit of theatre performances also resulted in the increase of condensation within the restored dome and caused paint to peel off (Figure 2.).

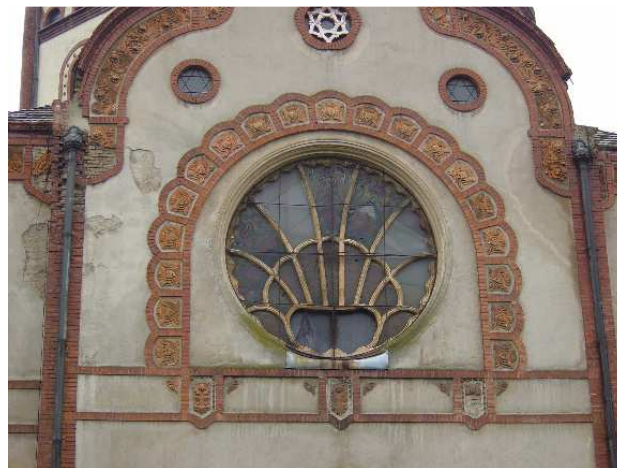
Figure 3. Detail of the north façade damaged by water (Authors photograph from 2000)

During the inspection of the Synagogue, the committee established that the exterior gutter system had been entirely destroyed, due to winds, causing water to leak and penetrate the walls of the building. The most serious damage was evident on the tambour of the Synagogue's main dome. One of the northern tambour window panes had been dislocated, which allowed water to penetrate the wooden structure of the roof. Obstructed horizontal drainage system also caused water to penetrate the tambour. The two main wooden joists – struts of the outer layer of the dome were damaged by the penetrating moisture, so in case this continued, stability of the dome was once again to be jeopardised. Roofing of the entrance section of the building was gravely damaged, which caused continuous rainwater dripping and leaking, leading to breakage in the wire lath layer of an interior vault. Through this opening, large quantities of atmospheric water poured into the Synagogue's interior. A great number of roof tiles had been dislocated during the years, and they also presented great hazard, since they allowed penetration of water and thus caused decay of the roof structure. The building was once again in very poor condition, in spite of all previously performed restoration works (Figure 3.). The

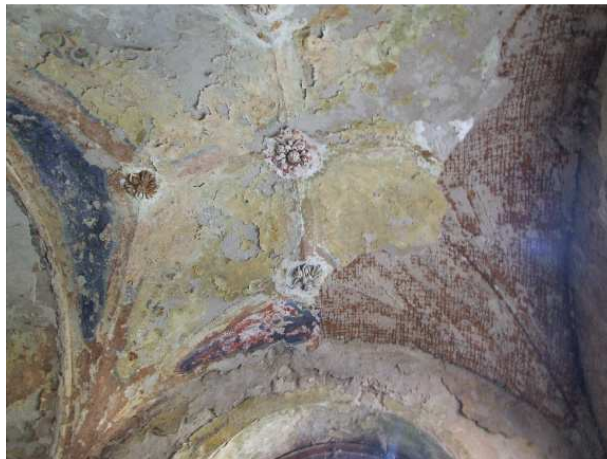
Figure 4. Damaged main entrance ceiling (Authors photograph from 2011.)

In 2007 the works on reconstruction and restoration of the roof structure were initiated [3]. In June, representatives of the contractor "Subiro" filed a complaint against anonymous persons who, during the weekend of 2-4 June 2007, had stolen the copper rain gutters and drainpipes from the Synagogue building. During August of the same year, unknown persons removed majority of the brass ornaments from the previously restored central chandelier of the Synagogue, thereby inflicting great damage [20]. At the beginning of 2008, the chief designer Gabor Demeter made "Amendments to the Main Architectural and Structural Design for Reconstruction and Restoration of the Outer Layer of Subotica Synagogue" [3]. The works on reconstructing and restoring the roof lasted until December 2010. These works did not include the roof section above the main entrance of the Synagogue (Figure 4.), which was especially endangered by atmospheric water after the vertical drainpipes had been stolen, or the zinc covering of thesegmental domes on the Synagogue's corners. Thus, in mid-2011, representatives of the Inter-Municipal Institute requested that the funds be allocated for intervention works, in order for these sections of the roof to be restored too. Urgent intervention of repairing these defects was not undertaken until mid-2012.
