Review paper

RISK MANAGEMENT ON MEDJEDJA DAM ON TAILING STORAGE FACILITY, OMARSKA MINE PRIJEDOR

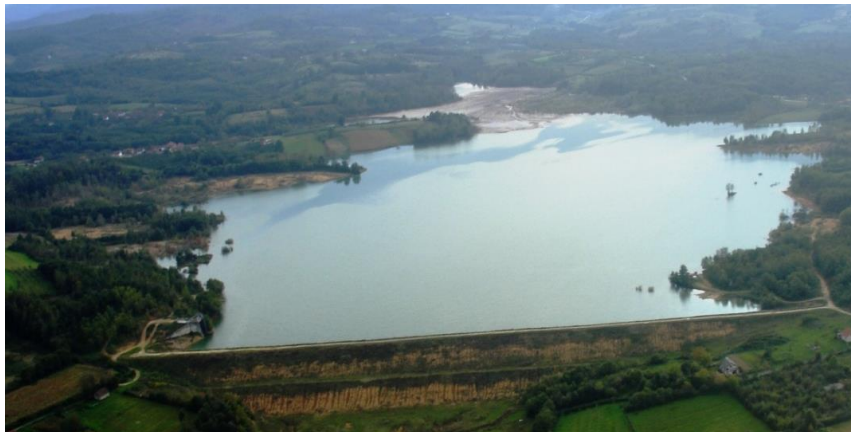
Picture 3. Dam and tailing storage facility

of this tailing storage facility is 163.5 ha [24]. The layout of the mud dam and tailing storage facility is shown in Picture 3.

The design elevation of the free water in the tailing storage facility is 196.70 m above sea level (asl). The average depth of free water in the lake is estimated at about 3-4 m, and the total amount of water at about 1.1-1.5 million m³ of free water. The amount of free water should be reduced to below 0.5 million m³ by further depositing mud. Part of the free water is returned through pipelines back to the GMS plant as process water and for the needs of the local population for irrigation of agricultural land [25].

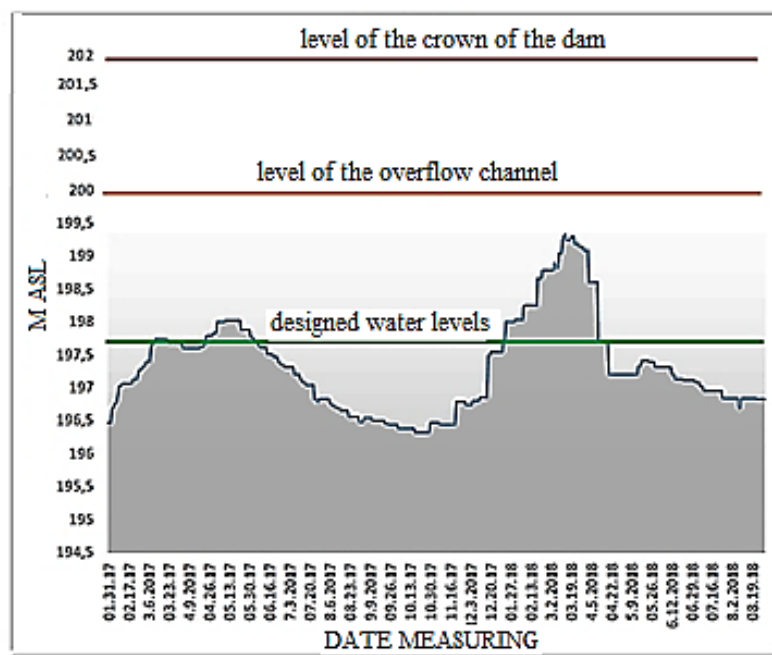
Picture 4. Graphic of water level in sedimentation lake during 2017 and 2018

The disposal of tailingmud at the "Gradina" tailing storage facility was completed in July 2017. At the time of active use of the tailing storage facility, the water level in the lake depended on the flow of hydro-mix from the GMS, the need for GMS for return water, rainfall and the contour of the tailing storage facility and evaporation. Control of the water level in the reservoir by months in 2017 and 2018 (end month August) is given in Picture4, [25,26].

In the observed period, the water level in the lake ranged from 196.32 (October 2017) to 199.29 (March 2017). The total oscillation of the water level was 2.97 m. Observed on a monthly basis, the oscillation of the maximum level was from -1.67 to +0.83 m and the minimum from -0.99 to +0.83 m [27]. Two situations are generally recorded, rising water levels from November to April / May and declining from April / May to October, with peaks in the spring months.

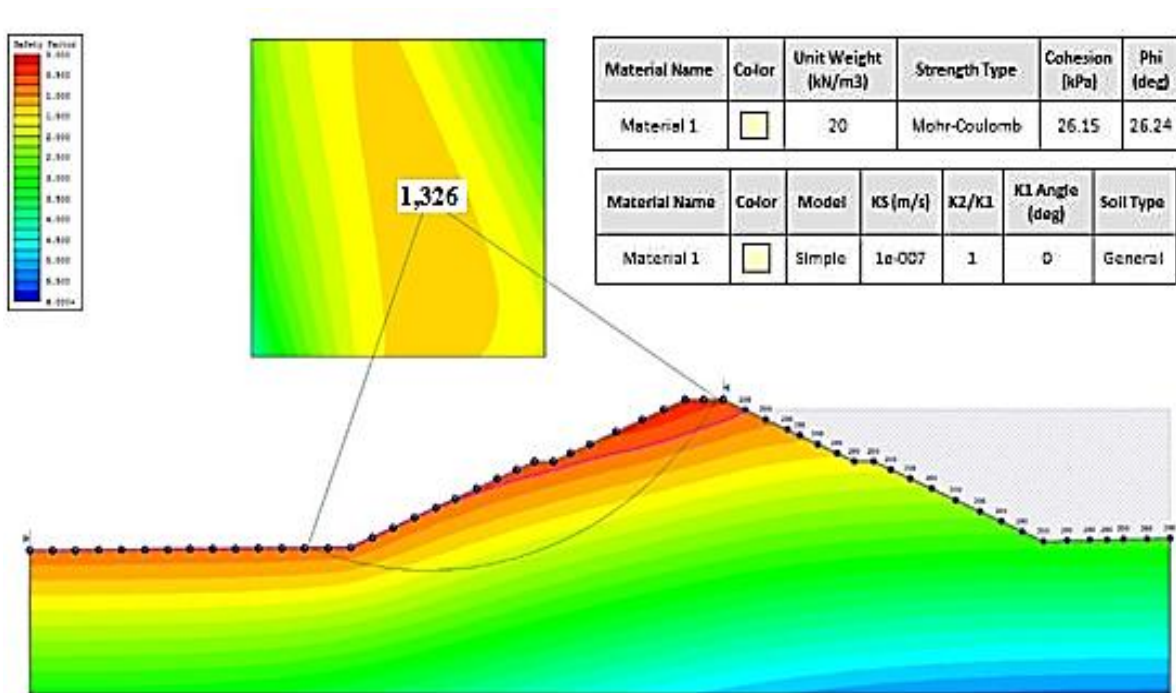
Picture 6. Stability factor of the dam in seismic conditions

It is advisable to use a method of determining the likelihood of an accident based on a safety factor in the preliminary assessment of the risk of dam's damages due to instability. Results of the calculation of the safety factor for static conditions on the characteristic profiles of the Medjedja dam in the Omarska Mine for the period 2015-2018 are shown in Table 1 and Picture 5, and the result of the stability factor under seismic conditions for profile 16, (most sensitive), is shown in Picture 6.

For a seismic safety factor of 1,326 determined for the Medjedja dam and the first category of buildings to which the Medjedja dam belongs, an annual probability of 1×10^{-4} is obtained, which can be interpreted as "small".
