*Review paper*

## THE TERRAIN CHARACTERISTICS OF RAILWAY ALONG THE ENTITY BORDER OF FEDERATION BIH – MAGLAJ, SECTION km 103+500 – MAGLAJ

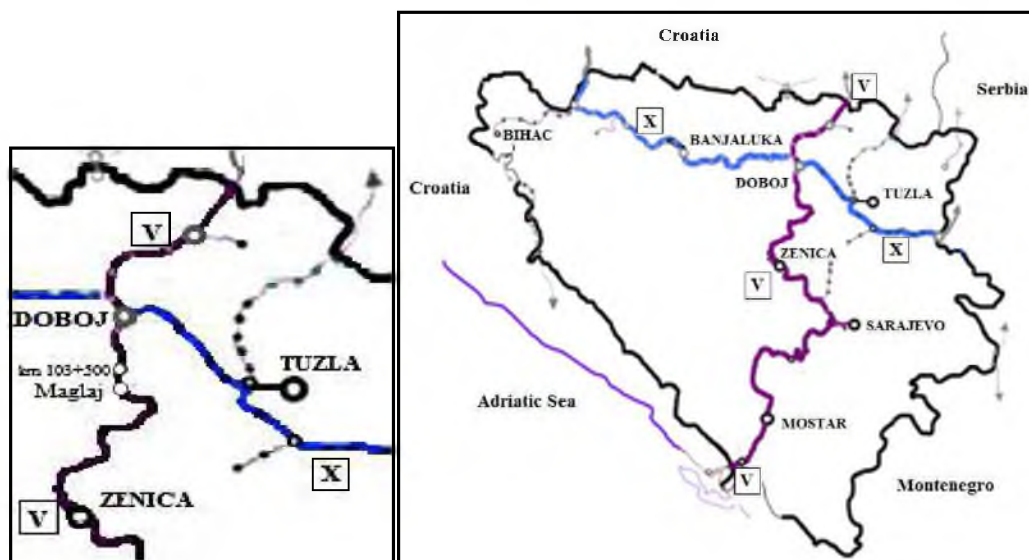
Figure 1. Section km 103+500 – Maglaj on the corridor V route in the Bosnia and Herzegovina

Complexity of the terrain geological composition along the route of the railway and impossibility of direct approach in a wider belt along the route (because of mine fields), limited research just on the very narrow belts around railway tracks. The railway has two tracks which mostly passes down base of the slopes and laid in the valley of the river Bosna. It represents an important part of the railway corridor V, Figure 1.

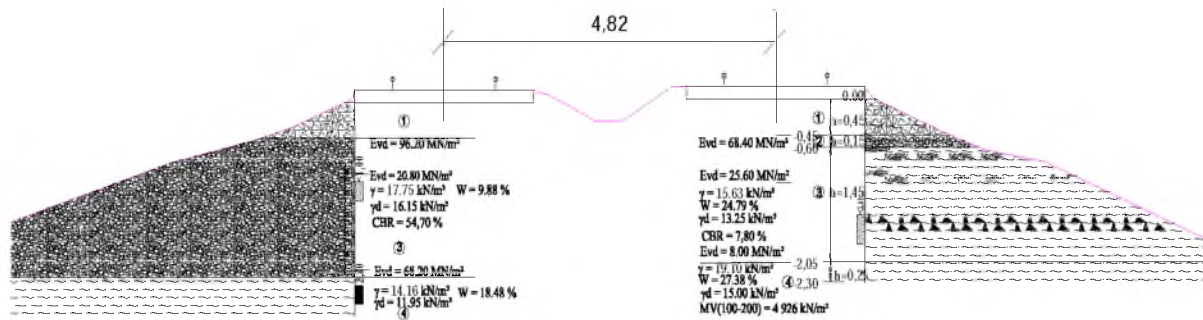
Research works have been done with task to define depth to the base soil, and went deeper of it for around 0.2 – 0.3 m. Average depth to the base soil is around 0,7 – 1,2 m. Along the old railway tracks depth to the base soil, or thickness of the embankment is less than the tracks which were made 70', situation is shown in Figure 2. The route is characterized by disordered peripheral canals, gaps and low maintenance of embankment.

Figure 2. Appearance of the levees along the new and old railway route tracks

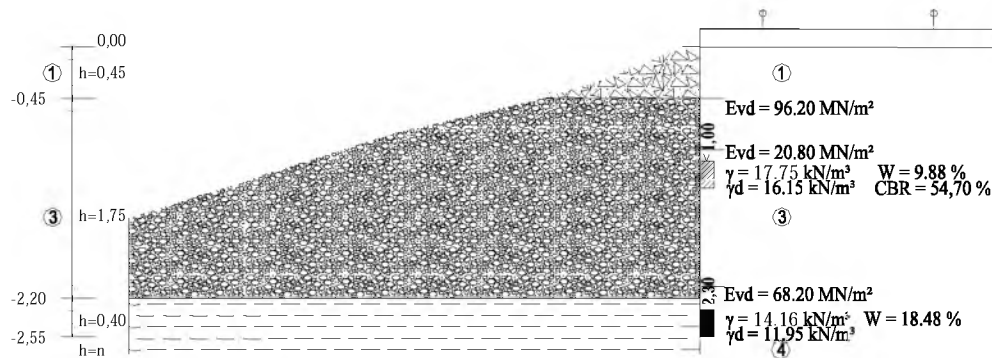
**Embankment** is built of different mixtures of materials such as natural soil material from borrow pits (silty clay, sand, sand, gravel) and technogenic materials (crushed aggregate with clayey sandy infill), Figure 3.

Figure 3. Embankment appearance on the new railway route tracks

Grain diameter which corresponds to the ordinate 60% -  $d_{60}$  range 0,951 to 29,13, and grain diameter which correspond to the ordinate 10% -  $d_{10}$  range from 0,0031 to 1,994, what indicate that materijal which is inbuilt in embankment have similar granulometric composition on the all examined sections. Grain diameter in earthen embankments which correspond to the ordinate 60% -  $d_{60}$  range from 0,0301 to 0,0722, and grain diameter which correspond to the ordinate 10% -  $d_{10}$  range from 0,0015 to 0,0028.

According to Allen Hazen formula soil unevenness degree  $C_u$  range from 4,50 to 688,60 what indicate that materijal of embankment has unequal composition, and in the earthen embankments soil unevenness degree  $C_u$  range from 25,62 to 31,79, which indicate that material in the earthen embankments has unequal composition.
